**ASBESTOS REINSPECTION  
SURVEY REPORT**

Court Fields School (Block E)  
Mantle Street  
Wellington  
TA21 8SW

Type of Report: Reinspection Survey  
Project / Job Number: RSP / O000694 / J146186  
Client Order Number: 8005  
Quote Number: O000694  
Sample Number(s): No samples were taken during the course of this survey.  
Reinspection Date(s): 7 Aug 2024  
Report Date: 29 Aug 2024

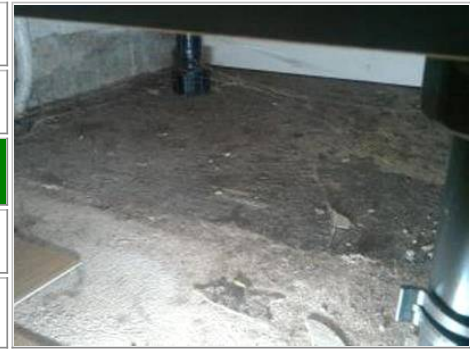
**Photo No. 1 - Bitumen adhesive below modern floor tiles continuing below kitchen units (possibly below new floor covering)**

E 002 Kitchen			
Well Bound Material (1)		Identified	
Chrysotile (1)		<b>D - Manage and Review</b>	
Material Assessment	Very Low	Priority Assessment	Low
-

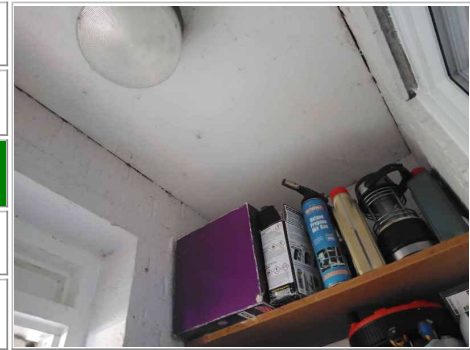
**Photo No. 2 - Fixed ceiling panels**

E 002A Circulation			
Asbestos Insulating Board (2)		Identified	
Chrysotile + Amosite (2)		<b>D - Manage and Review</b>	
Material Assessment	Low	Priority Assessment	Low
-

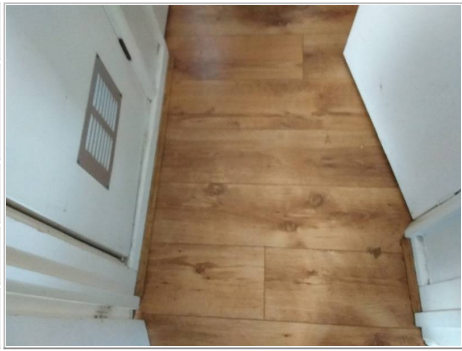
**Photo No. 4 - Vinyl floor tiles (beige) below laminate flooring and bitumen adhesive below (possibly below new floor covering) (as sample AN001136)**

E 004 Circulation			
Reinforced Composite + Well Bound Material (1)		Strongly Presumed	
Chrysotile (1)		<b>D - Manage and Review</b>	
Material Assessment	Very Low	Priority Assessment	Low
-

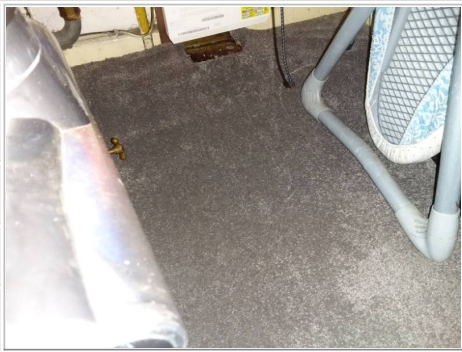
**Photo No. 5 - Vinyl floor tiles (beige) below carpet and bitumen adhesive below (possibly below new floor covering) (as sample AN001136)**

E 004A Cupboard			
Reinforced Composite + Well Bound Material (1)		Strongly Presumed	
Chrysotile (1)		<b>D - Manage and Review</b>	
Material Assessment	Very Low	Priority Assessment	Low
-

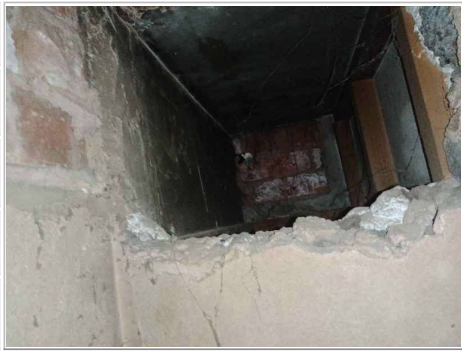
E 004B Cupboard - Panels within alcove at high level to north side of room

**Photo No. 6 - Panels within alcove at high level to north side of room**

E 004B Cupboard			
Asbestos Insulating Board (2)		Identified	
Chrysotile + Amosite (2)		<b>C - Repair or Remove</b>	
Material Assessment	Med	Priority Assessment	Low
Repair/encapsulation recommended

Asbestos containing material showing some signs of deterioration / damage and / or vulnerable to further damage. This material either requires repair, encapsulation or removal in the near future, depending on the requirement of the client, although it is not posing a significant hazard to persons using the building provided it remains undisturbed.

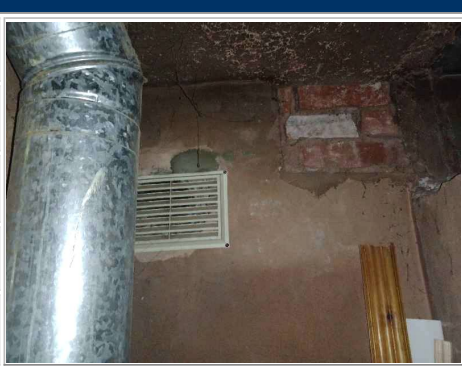
**Photo No. 7 - Flue pipe within vent to west side of room**

E 004B Cupboard			
Asbestos Cement (1)		Identified	
Chrysotile (1)		<b>D - Manage and Review</b>	
Material Assessment	Very Low	Priority Assessment	Low
-

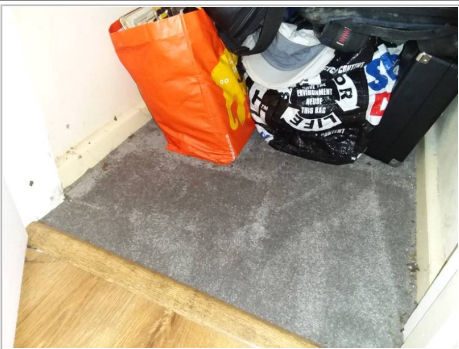
**Photo No. 8 - Vinyl floor tiles (beige) below carpet and bitumen adhesive below (possibly below new floor covering) (as sample AN001136)**

E 004C Airing Cupboard			
Reinforced Composite + Well Bound Material (1)		Strongly Presumed	
Chrysotile (1)		<b>D - Manage and Review</b>	
Material Assessment	Very Low	Priority Assessment	Low
-

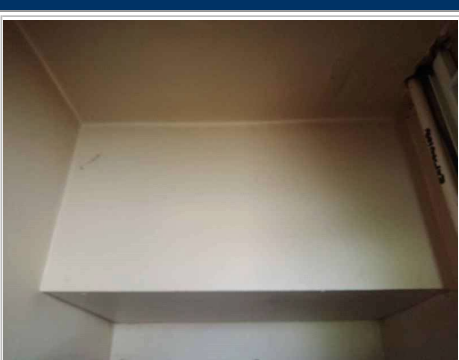
E 004C	Airing Cupboard	9		Boxing panels at high level (as sample AN001138)	<1 m <sup>2</sup>	Strongly Presumed	Asbestos Insulating Board (2)	Chrysotile + Amosite (2)	Good Condition (0)	Surface Sealed (1)	Low	Low	Low	D - Manage and Review	-	N/A	Aug 2025	No Change
E 005	Bedroom	10		Vinyl floor tiles (beige) below carpet and bitumen adhesive below (possibly below new floor covering) (as sample AN001136)	6 - 8 m <sup>2</sup>	Strongly Presumed	Reinforced Composite + Well Bound Material (1)	Chrysotile (1)	Low Damage (1)	Completely Sealed (0)	Low	Very Low	Low	D - Manage and Review	-	N/A	Aug 2025	Unable to Access - New floor covering
E 005A	Cupboard	11		Vinyl floor tiles (beige) below carpet and bitumen adhesive below (possibly below new floor covering) (as sample AN001136)	<1 m <sup>2</sup>	Strongly Presumed	Reinforced Composite + Well Bound Material (1)	Chrysotile (1)	Low Damage (1)	Completely Sealed (0)	Low	Very Low	Low	D - Manage and Review	-	N/A	Aug 2025	Unable to Access - New floor covering

**Photo No. 9 - Boxing panels at high level (as sample AN001138)**

E 004C Airing Cupboard			
Asbestos Insulating Board (2)		Strongly Presumed	
Chrysotile + Amosite (2)		<b>D - Manage and Review</b>	
Material Assessment	Low	Priority Assessment	Low
-

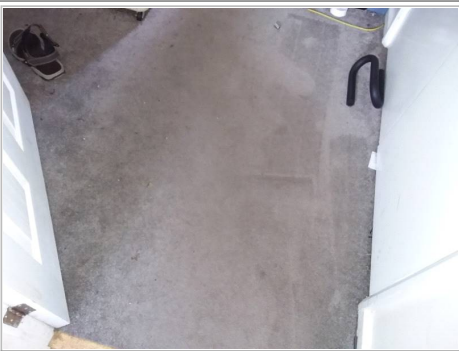
**Photo No. 10 - Vinyl floor tiles (beige) below carpet and bitumen adhesive below (possibly below new floor covering) (as sample AN001136)**

E 005 Bedroom			
Reinforced Composite + Well Bound Material (1)		Strongly Presumed	
Chrysotile (1)		<b>D - Manage and Review</b>	
Material Assessment	Very Low	Priority Assessment	Low
-

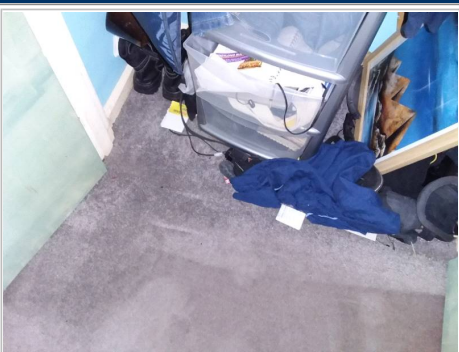
**Photo No. 11 - Vinyl floor tiles (beige) below carpet and bitumen adhesive below (possibly below new floor covering) (as sample AN001136)**

E 005A Cupboard			
Reinforced Composite + Well Bound Material (1)		Strongly Presumed	
Chrysotile (1)		<b>D - Manage and Review</b>	
Material Assessment	Very Low	Priority Assessment	Low
-

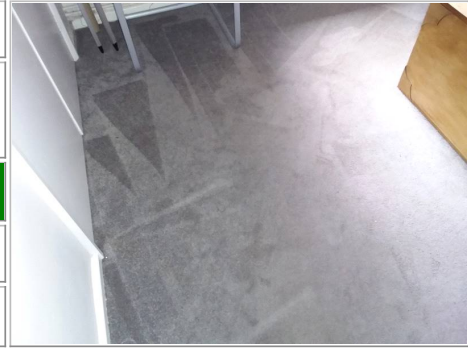
E 006	Bedroom	12		Vinyl floor tiles (beige) below carpet and bitumen adhesive below (possibly below new floor covering) (as sample AN001136)	8 - 10 m <sup>2</sup>	Strongly Presumed	Reinforced Composite + Well Bound Material (1)	Chrysotile (1)	Low Damage (1)	Completely Sealed (0)	Low	Very Low	Low	D - Manage and Review	-	N/A	Aug 2025	Unable to Access - New floor covering
E 006A	Cupboard	13		Vinyl floor tiles (beige) below carpet and bitumen adhesive below (possibly below new floor covering) (as sample AN001136)	<1 m <sup>2</sup>	Strongly Presumed	Reinforced Composite + Well Bound Material (1)	Chrysotile (1)	Low Damage (1)	Completely Sealed (0)	Low	Very Low	Low	D - Manage and Review	-	N/A	Aug 2025	Unable to Access - New floor covering
E 007	Bedroom	14		Vinyl floor tiles (beige) below carpet and bitumen adhesive below (possibly below new floor covering) (as sample AN001136)	6 - 8 m <sup>2</sup>	Strongly Presumed	Reinforced Composite + Well Bound Material (1)	Chrysotile (1)	Low Damage (1)	Completely Sealed (0)	Low	Very Low	Low	D - Manage and Review	-	N/A	Aug 2025	Unable to Access - New floor covering

**Photo No. 12 - Vinyl floor tiles (beige) below carpet and bitumen adhesive below (possibly below new floor covering) (as sample AN001136)**

E 006 Bedroom			
Reinforced Composite + Well Bound Material (1)		Strongly Presumed	
Chrysotile (1)		<b>D - Manage and Review</b>	
Material Assessment	Very Low	Priority Assessment	Low
-

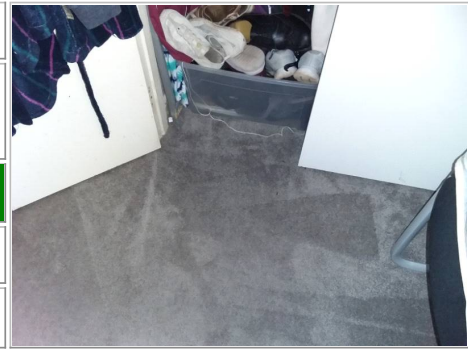
**Photo No. 13 - Vinyl floor tiles (beige) below carpet and bitumen adhesive below (possibly below new floor covering) (as sample AN001136)**

E 006A Cupboard			
Reinforced Composite + Well Bound Material (1)		Strongly Presumed	
Chrysotile (1)		<b>D - Manage and Review</b>	
Material Assessment	Very Low	Priority Assessment	Low
-

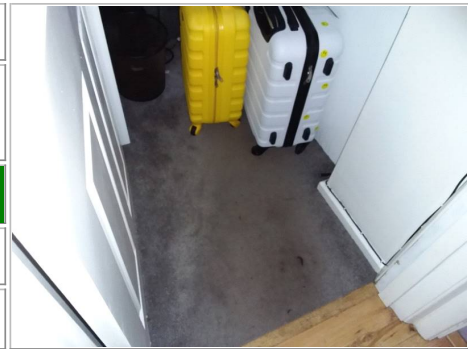
**Photo No. 14 - Vinyl floor tiles (beige) below carpet and bitumen adhesive below (possibly below new floor covering) (as sample AN001136)**

E 007 Bedroom			
Reinforced Composite + Well Bound Material (1)		Strongly Presumed	
Chrysotile (1)		<b>D - Manage and Review</b>	
Material Assessment	Very Low	Priority Assessment	Low
-

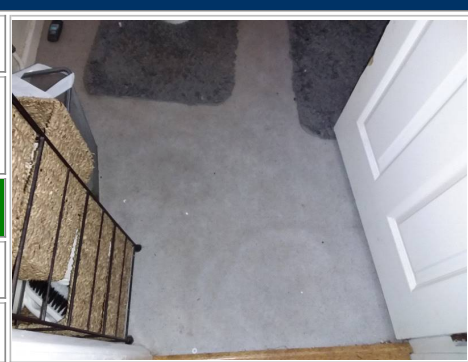
E 008	Bathroom	15	AN001140 (J062764)	Vinyl floor tiles (grey) below modern screed below modern sheeting and bitumen adhesive below	Unknown	Identified	Reinforced Composite + Well Bound Material (1)	Chrysotile (1)	Low Damage (1)	Completely Sealed (0)	Very Low	Very Low	Low	D - Manage and Review	-	N/A	Aug 2025	Unable to Access - New floor covering

**Photo No. 15 - Vinyl floor tiles (grey) below modern screed below modern sheeting and bitumen adhesive below**

E 008 Bathroom			
Reinforced Composite + Well Bound Material (1)		Identified	
Chrysotile (1)		<b>D - Manage and Review</b>	
Material Assessment	Very Low	Priority Assessment	Low
-

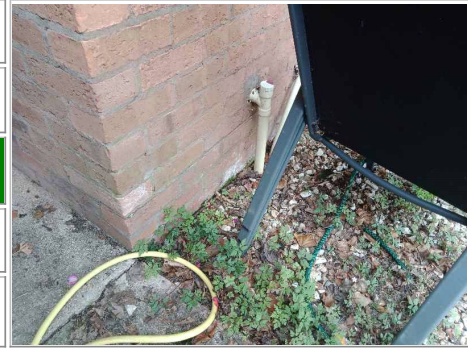
Photo No. 16 - Damp proof course

External			
Well Bound Material (1)		Identified	
Chrysotile (1)		<b>D - Manage and Review</b>	
Material Assessment	Very Low	Priority Assessment	Very Low
-

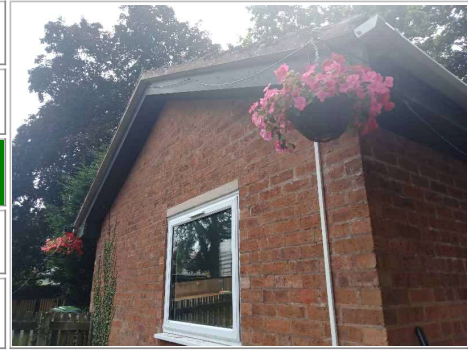
Photo No. 17 - Undertile edging to north, south and east sides of property

External			
Asbestos Cement (1)		Identified	
Chrysotile (1)		<b>D - Manage and Review</b>	
Material Assessment	Very Low	Priority Assessment	Very Low
-
