ASBESTOS REINSPECTION SURVEY REPORT

**Court Fields School (Block C)
Mantle Street
Wellington
TA21 8SW**

Original Report Type: Management Survey

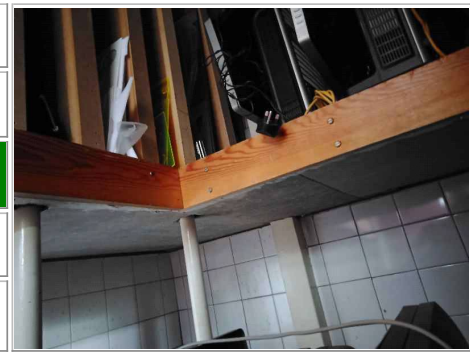
Photo No. 1 - Fixed panels to underside of bench

C 001 Store			
Asbestos Cement (1)		Identified	
Chrysotile (1)		D - Manage and Review	
Material Assessment	Very Low	Priority Assessment	Low
-

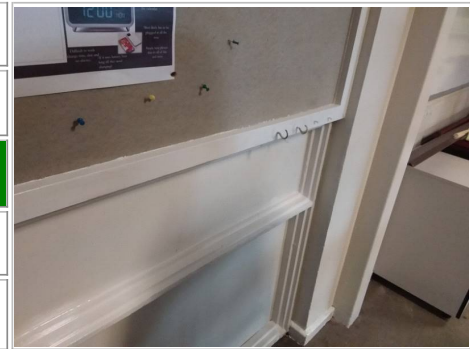
Photo No. 2 - Sub-window panel (1 no.) to southeast corner of room (as sample DA005517)

C 003 Resistant Materials			
Asbestos Cement (1)		Strongly Presumed	
Chrysotile (1)		D - Manage and Review	
Material Assessment	Very Low	Priority Assessment	Low
-

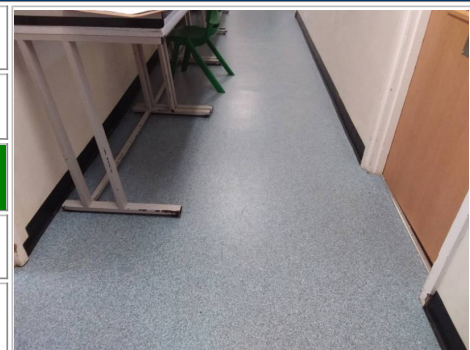
Photo No. 3 - Vinyl floor tiles (beige) and bitumen adhesive below (possibly below new floor covering)

C 011A Circulation			
Well Bound Material (1)		Identified	
Chrysotile (1)		D - Manage and Review	
Material Assessment	Very Low	Priority Assessment	Low
-

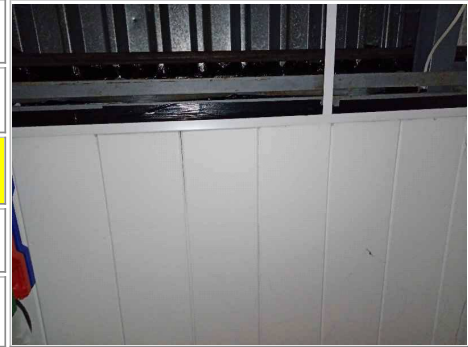
Photo No. 4 - Fixed ceiling panels to east side of room (small areas require remedial action) (as sample DA005504)

C 012 Store			
Asbestos Insulating Board (2)		Strongly Presumed	
Chrysotile + Amosite (2)		C - Repair or Remove	
Material Assessment	Med	Priority Assessment	Very Low
Repair/encapsulation recommended

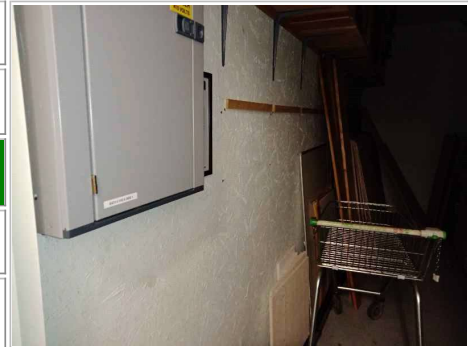
Photo No. 5 - Textured coating to north wall (as sample DA005508)

C 012 Store			
Textured Coating (1)		Strongly Presumed	
Chrysotile (1)		D - Manage and Review	
Material Assessment	Very Low	Priority Assessment	Very Low
-

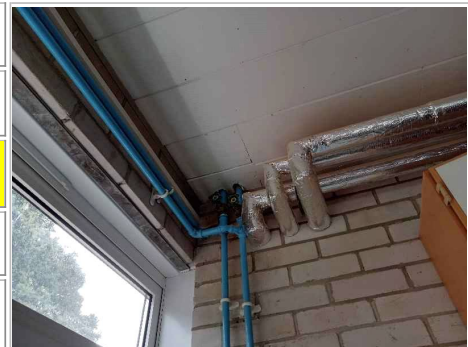
Photo No. 6 - Fixed ceiling panels (small areas require remedial action) (as sample DA005504)

C 013 Resistant Materials			
Asbestos Insulating Board (2)		Strongly Presumed	
Chrysotile + Amosite (2)		C - Repair or Remove	
Material Assessment	Med	Priority Assessment	Low
Repair/encapsulation recommended

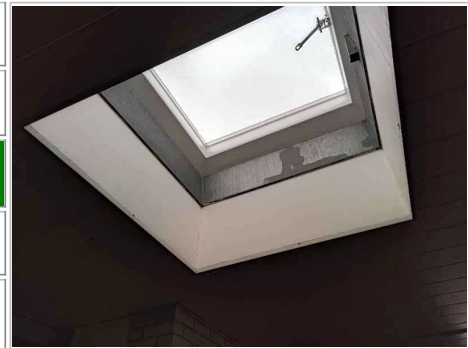
Photo No. 7 - Skylight cheeks (as sample DA005505)

C 013 Resistant Materials			
Asbestos Insulating Board (2)		Strongly Presumed	
Chrysotile + Amosite (2)		D - Manage and Review	
Material Assessment	Low	Priority Assessment	Low
-

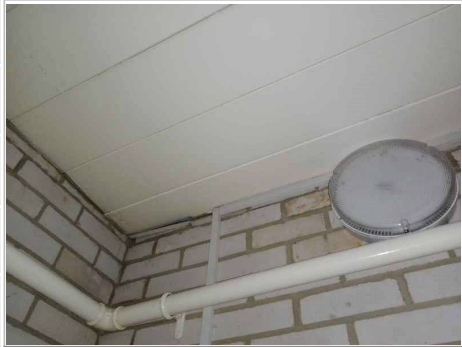
Photo No. 8 - Fixed ceiling panels (small areas require remedial action) (as sample DA005504)

C 013A Store			
Asbestos Insulating Board (2)		Strongly Presumed	
Chrysotile + Amosite (2)		C - Repair or Remove	
Material Assessment	Med	Priority Assessment	Low
Repair/encapsulation recommended

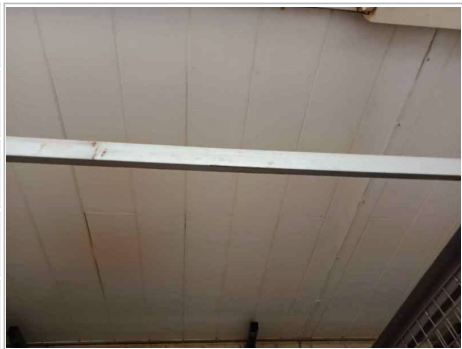
Photo No. 9 - Fixed ceiling panels (as sample DA005504)

C 014 Kiln			
Asbestos Insulating Board (2)		Strongly Presumed	
Chrysotile + Amosite (2)		D - Manage and Review	
Material Assessment	Low	Priority Assessment	Low
-

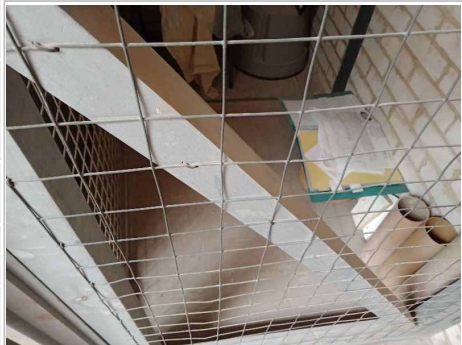
Photo No. 10 - Vinyl floor tiles (beige) and bitumen adhesive below (as sample DA005503)

C 014 Kiln			
Reinforced Composite + Well Bound Material (1)		Strongly Presumed	
Chrysotile (1)		D - Manage and Review	
Material Assessment	Very Low	Priority Assessment	Low
-

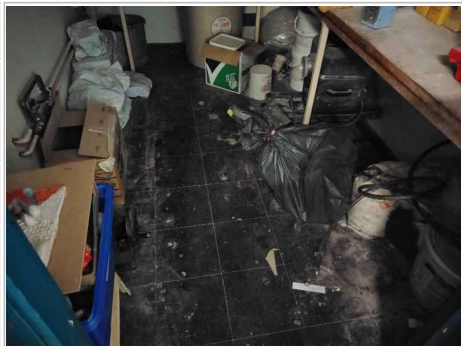
Photo No. 11 - Vinyl floor tiles (dark brown) and bitumen adhesive below (as sample DA005502)

C 015 Store			
Reinforced Composite + Well Bound Material (1)		Strongly Presumed	
Chrysotile (1)		D - Manage and Review	
Material Assessment	Very Low	Priority Assessment	Low
-

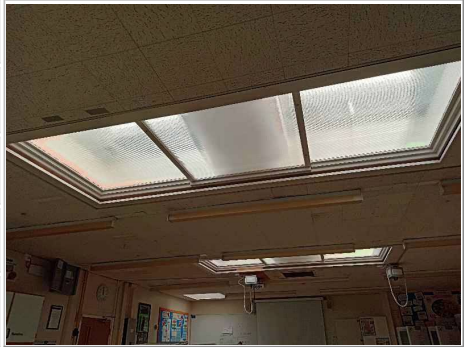
Photo No. 12 - Skylight cheeks to skylights (4 no.) continuing above sealed sliding windows (as sample DA005505)

C 016 Food Technology			
Asbestos Insulating Board (2)		Strongly Presumed	
Chrysotile + Amosite (2)		D - Manage and Review	
Material Assessment	Low	Priority Assessment	Low
-

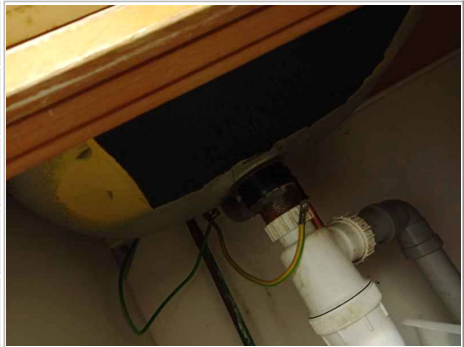
Photo No. 13 - Bitumen pads to underside of sink and drainer

C 017 Prep			
Well Bound Material (1)		Identified	
Chrysotile (1)		D - Manage and Review	
Material Assessment	Very Low	Priority Assessment	Low
-

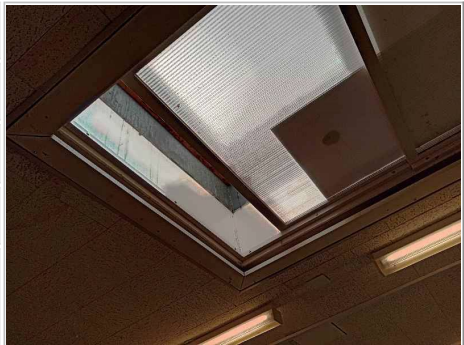
Photo No. 14 - Skylight cheeks to skylights (3 no.) continuing above sealed sliding windows (small areas require remedial action) (as sample DA005505)

C 018 Food Technology			
Asbestos Insulating Board (2)		Strongly Presumed	
Chrysotile + Amosite (2)		C - Repair or Remove	
Material Assessment	Med	Priority Assessment	Low
Recommended to be closed and screwed shut - Repair / encapsulation recommended

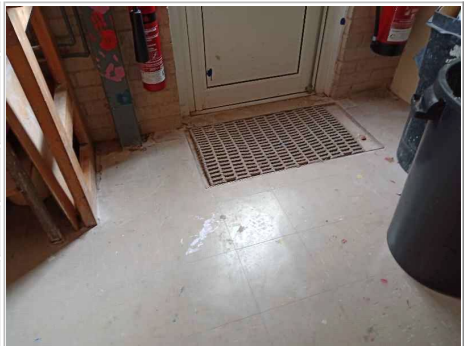
Photo No. 15 - Vinyl floor tiles (beige) and bitumen adhesive below (small areas requires remedial action)

C 019 Art			
Reinforced Composite + Well Bound Material (1)		Identified	
Chrysotile (1)		C - Repair or Remove	
Material Assessment	Very Low	Priority Assessment	Med
Damaged tiles removed, bitumen sealed with PVA - 27 Jul 23 - Roberts - Ref: SL-23093 - Further work required

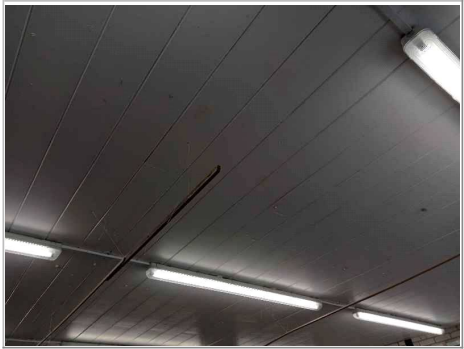
Photo No. 16 - Fixed ceiling panels (small areas require remedial action)			
C 019 Art			
Asbestos Insulating Board (2)		Identified	
Chrysotile + Amosite (2)		C - Repair or Remove	
Material Assessment	Med	Priority Assessment	Low
Repair/encapsulation recommended

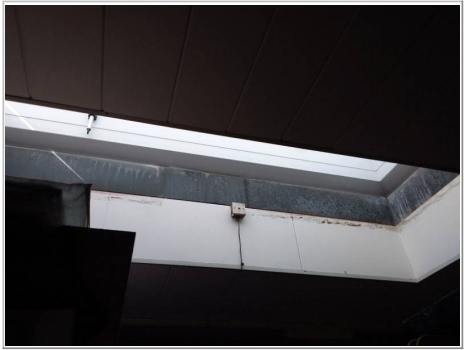
Photo No. 17 - Skylight cheeks to skylights (2 no.)			
C 019 Art			
Asbestos Insulating Board (2)		Identified	
Chrysotile + Amosite (2)		D - Manage and Review	
Material Assessment	Low	Priority Assessment	Low
-

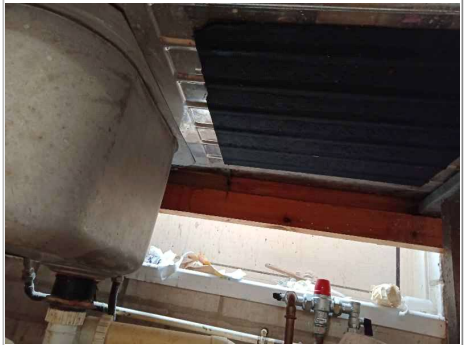
Photo No. 18 - Bitumen pad to underside of drainer adjacent northernmost external door to east side of room			
C 019 Art			
Well Bound Material (1)		Identified	
Chrysotile (1)		D - Manage and Review	
Material Assessment	Very Low	Priority Assessment	Low
-

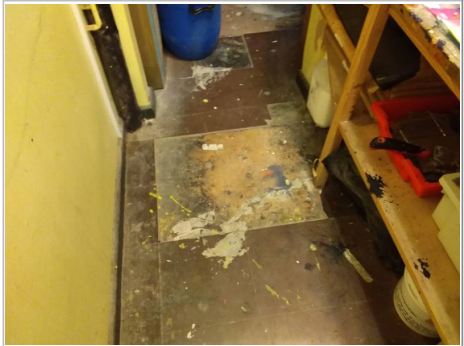
Photo No. 19 - Bitumen adhesive to floor (original floor tiles removed) (as sample DA005502)			
C 020 Store			
Reinforced Composite + Well Bound Material (1)		Strongly Presumed	
Chrysotile (1)		D - Manage and Review	
Material Assessment	Very Low	Priority Assessment	Low
Floor tiles removed, bitumen sealed with PVA - 27 Jul 23 - Roberts - Ref: SL-23093

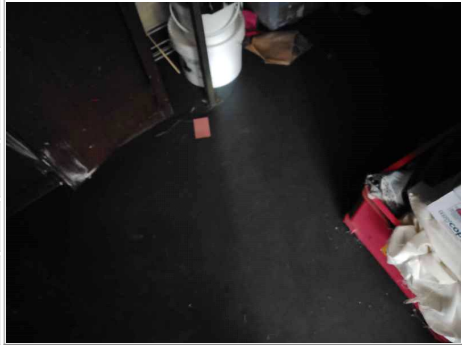
Photo No. 20 - Bitumen adhesive to floor (original floor tiles removed)

C 021 Store			
Reinforced Composite + Well Bound Material (1)		Identified	
Chrysotile (1)		D - Manage and Review	
Material Assessment	Very Low	Priority Assessment	Low
Floor tiles removed, bitumen sealed with PVA - 27 Jul 23 - Roberts - Ref: SL-23093

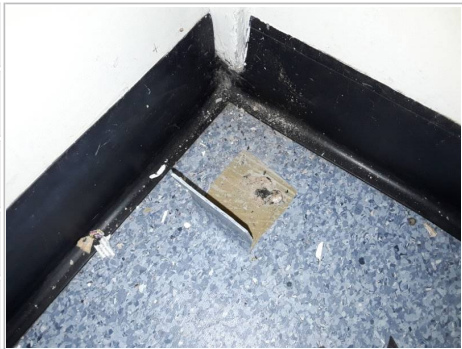
Photo No. 21 - Bitumen adhesive to floor below modern floor screed below modern vinyl floor sheeting

C 022 Circulation			
Well Bound Material (1)		Identified	
Chrysotile (1)		D - Manage and Review	
Material Assessment	Very Low	Priority Assessment	Low
-

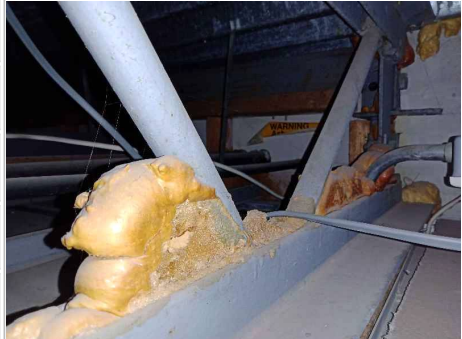
Photo No. 22 - Firebreak panels in ceiling void adjacent Office C004 (accessed via ceiling void in Art C 024) (as sample DG004868)

C 022 Circulation			
Asbestos Insulating Board (2)		Strongly Presumed	
Chrysotile + Amosite (2)		D - Manage and Review	
Material Assessment	Low	Priority Assessment	Low
-

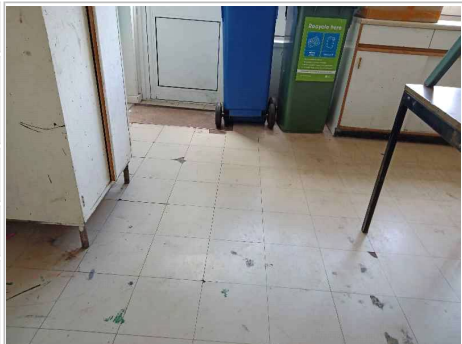
Photo No. 23 - Vinyl floor tiles (cream) and bitumen adhesive below (small areas require remedial action)

C 024 Art			
Reinforced Composite + Well Bound Material (1)		Identified	
Chrysotile (1)		C - Repair or Remove	
Material Assessment	Very Low	Priority Assessment	Med
REFER TO MANAGED AREAS WITHIN ROOM PRIOR TO WORKS - Removal recommended

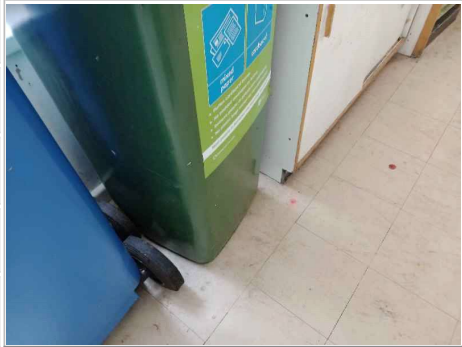
Photo No. 24 - Vinyl floor tiles (beige) to small areas of room and bitumen adhesive below

C 024 Art			
Well Bound Material (1)		Identified	
Chrysotile (1)		D - Manage and Review	
Material Assessment	Very Low	Priority Assessment	Low
REFER TO MANAGED AREAS WITHIN ROOM PRIOR TO WORKS

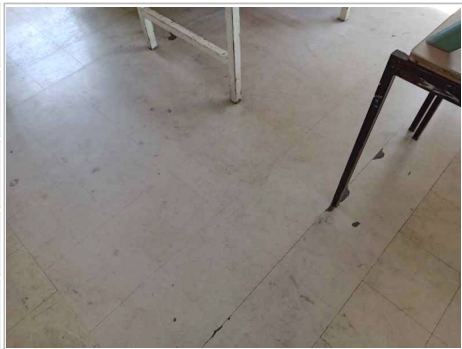
Photo No. 25 - Vinyl floor tiles (lighter cream) to centre of room and bitumen adhesive below

C 024 Art			
Well Bound Material (1)		Identified	
Chrysotile (1)		D - Manage and Review	
Material Assessment	Very Low	Priority Assessment	Low
REFER TO MANAGED AREAS WITHIN ROOM PRIOR TO WORKS

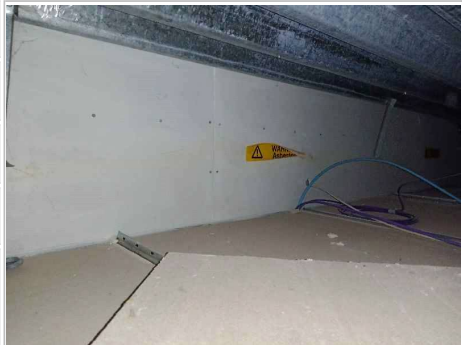
Photo No. 26 - Firebreak panels in ceiling void above door and surround leading to Art C 019 and associated debris

C 024 Art			
Asbestos Insulating Board (2)		Identified	
Chrysotile + Amosite (2)		C - Repair or Remove	
Material Assessment	Med	Priority Assessment	Low
MANAGED AREA - THIS CEILING VOID IS NOT SAFE TO ACCESS UNTIL REMEDIAL ACTION IS CARRIED OUT

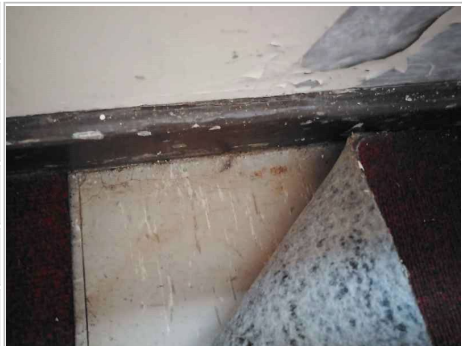
Photo No. 27 - Vinyl floor tiles (beige) below carpet tiles and bitumen adhesive below

C 025A Office			
Reinforced Composite + Well Bound Material (1)		Identified	
Chrysotile (1)		D - Manage and Review	
Material Assessment	Very Low	Priority Assessment	Low
-

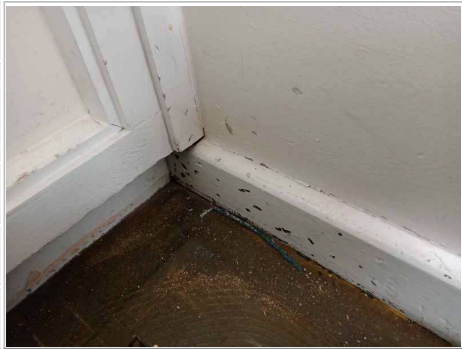
Photo No. 28 - Vinyl floor tiles (brown) below carpet and bitumen adhesive below

C 032 Office			
Reinforced Composite + Well Bound Material (1)		Identified	
Chrysotile (1)		D - Manage and Review	
Material Assessment	Very Low	Priority Assessment	Low
-

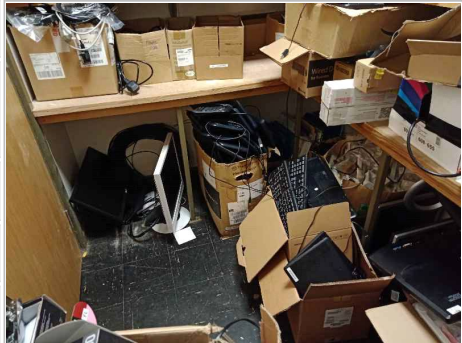
Photo No. 29 - Vinyl floor tiles (black) and bitumen adhesive below (small areas require remedial action) (as sample DA005518)

C 033 Store			
Reinforced Composite + Well Bound Material (1)		Strongly Presumed	
Chrysotile (1)		C - Repair or Remove	
Material Assessment	Very Low	Priority Assessment	Very Low
Removal recommended

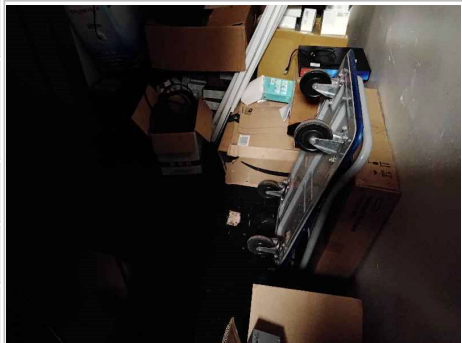
Photo No. 30 - Vinyl floor tiles (black) and bitumen adhesive below (small areas require remedial action)

C 035 Store			
Reinforced Composite + Well Bound Material (1)		Identified	
Chrysotile (1)		C - Repair or Remove	
Material Assessment	Very Low	Priority Assessment	Very Low
Removal recommended

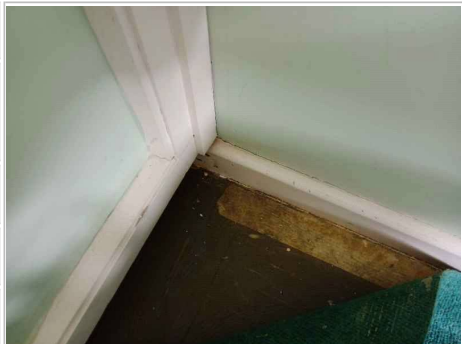
Photo No. 31 - Vinyl floor tiles (brown) below carpet and bitumen adhesive below

C 036 Office			
Reinforced Composite + Well Bound Material (1)		Identified	
Chrysotile (1)		D - Manage and Review	
Material Assessment	Very Low	Priority Assessment	Low
-

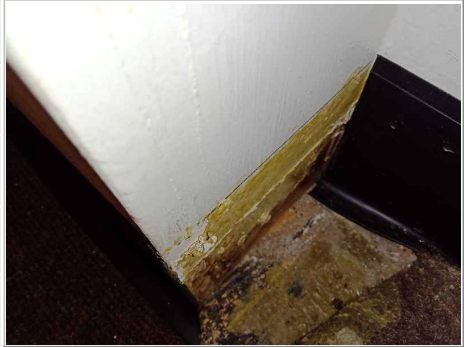
Photo No. 32 - Bitumen adhesive to floor below damaged modern screed below carpet

C 038A ICT			
Well Bound Material (1)		Identified	
Chrysotile (1)		D - Manage and Review	
Material Assessment	Very Low	Priority Assessment	Low
-

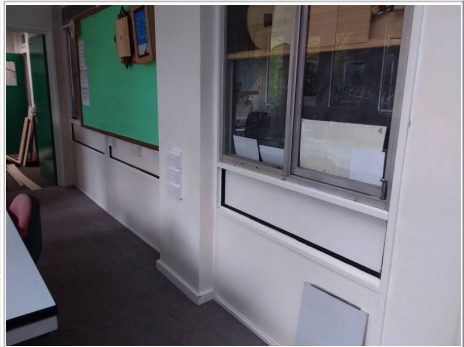
Photo No. 33 - Sub-window panels (3 no.) to north side of room (as sample DA005517)

C 038C Control Technology			
Asbestos Cement (1)		Strongly Presumed	
Chrysotile (1)		D - Manage and Review	
Material Assessment	Very Low	Priority Assessment	Low
-

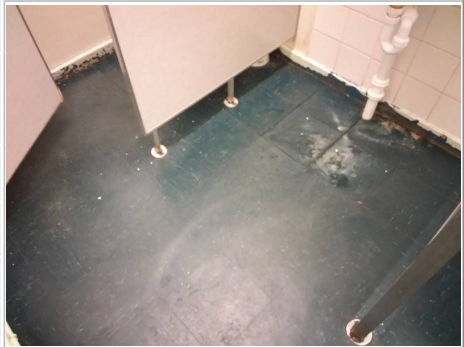
Photo No. 34 - Bitumen adhesive to floor (original floor tiles removed)

C 040 Male Staff W.C.			
Reinforced Composite + Well Bound Material (1)		Identified	
Chrysotile (1)		D - Manage and Review	
Material Assessment	Very Low	Priority Assessment	Low
Floor tiles removed, bitumen sealed with PVA - 27 Jul 23 - Roberts - Ref: SL-23093

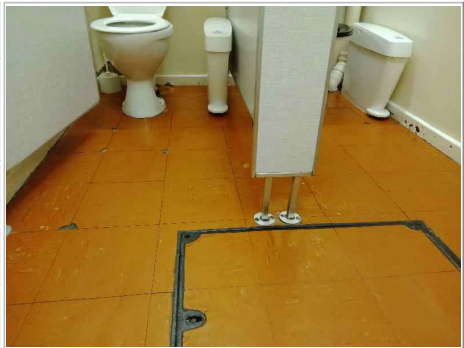
Photo No. 35 - Vinyl floor tiles (orange) and bitumen adhesive below (small areas require remedial action)

C 041 Female Staff W.C.			
Reinforced Composite + Well Bound Material (1)		Identified	
Chrysotile (1)		C - Repair or Remove	
Material Assessment	Very Low	Priority Assessment	Low
Removal recommended

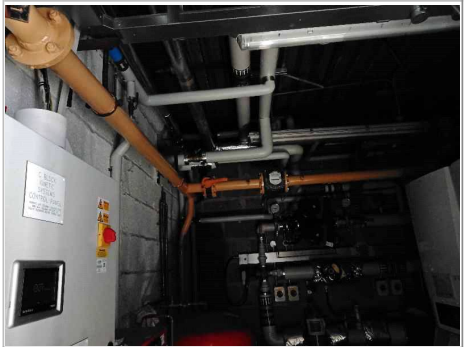
Photo No. 36 - Gaskets to pipework			
C 042 Boiler Room			
Asbestos Textiles/Paper (2)		Identified	
Chrysotile (1)		D - Manage and Review	
Material Assessment	Low	Priority Assessment	Very Low
-

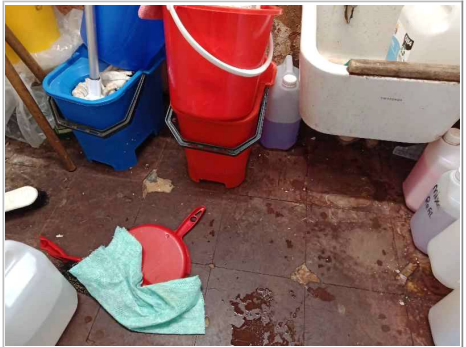
Photo No. 37 - Vinyl floor tiles (brown) and bitumen adhesive below (small areas require remedial action)			
C 043 Cleaner's Cupboard			
Reinforced Composite + Well Bound Material (1)		Identified	
Chrysotile (1)		C - Repair or Remove	
Material Assessment	Very Low	Priority Assessment	Low
Removal recommended

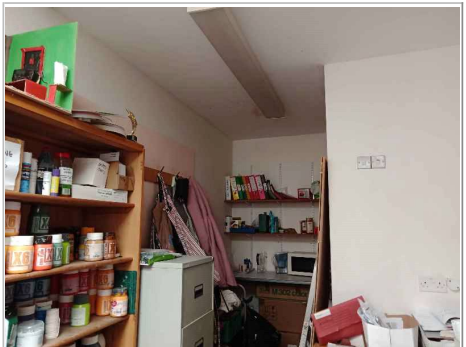
Photo No. 38 - Textured coating to north, east and west walls			
C 050 Office			
Textured Coating (1)		Identified	
Chrysotile (1)		D - Manage and Review	
Material Assessment	Very Low	Priority Assessment	Low
Encapsulated - 27 Jul 23 - Roberts - Ref: SL-23093

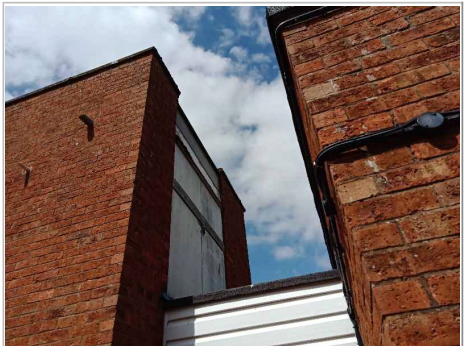
Photo No. 39 - Horizontal panel at high level to east side of Meters C 045 - unable to reach to sample			
External			
Asbestos Cement (1)		Presumed	
Crocidolite (or unknown) (3)		D - Manage and Review	
Material Assessment	Low	Priority Assessment	Very Low
Sample prior to disturbance

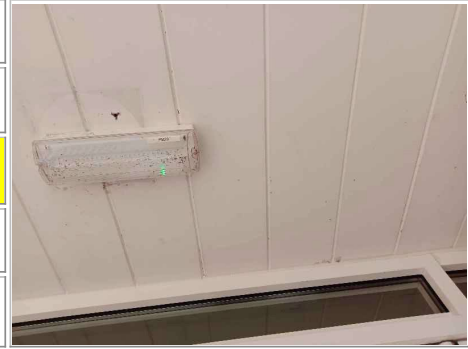
Photo No. 40 - Fixed ceiling panels to entrance porch to Circulation C 039 (small areas require remedial action)

External			
Asbestos Insulating Board (2)		Identified	
Amosite (2)		C - Repair or Remove	
Material Assessment	Med	Priority Assessment	Very Low
Repair/encapsulation recommended

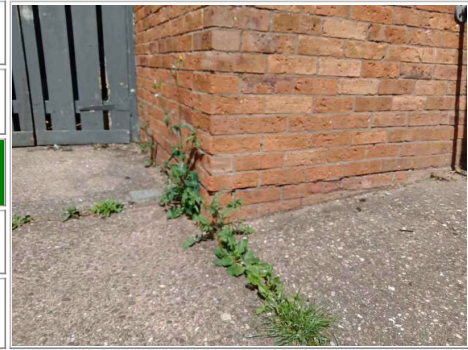
Photo No. 41 - Damp proof course

External			
Well Bound Material (1)		Identified	
Chrysotile (1)		D - Manage and Review	
Material Assessment	Very Low	Priority Assessment	Very Low
-
