ASBESTOS REINSPECTION SURVEY REPORT

Court Fields School (Block B)
Mantle Street
Wellington
TA21 8SW

Type of Report: Reinspection Survey
Project / Job Number: RSP / O000694 / J146184
Client Order Number: 8005
Quote Number: O000694
Sample Number(s): No samples were taken during the course of this survey.
Reinspection Date(s): 7 Aug 2024
Report Date: 29 Aug 2024

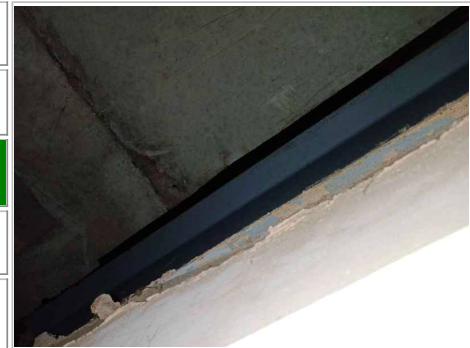
Photo No. 2 - Damp proof course above steel joists within ceiling void (as sample DA005536)

B 002 Circulation			
Well Bound Material (1)		Strongly Presumed	
Chrysotile (1)		D - Manage and Review	
Material Assessment	Very Low	Priority Assessment	Low
-

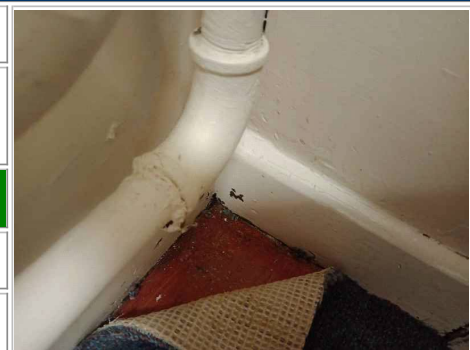
Photo No. 4 - Vinyl floor tiles (dark grey) and bitumen adhesive below			
B 004 Staff W.C.			
Reinforced Composite + Well Bound Material (1)		Identified	
Chrysotile (1)		D - Manage and Review	
Material Assessment	Very Low	Priority Assessment	Low
-

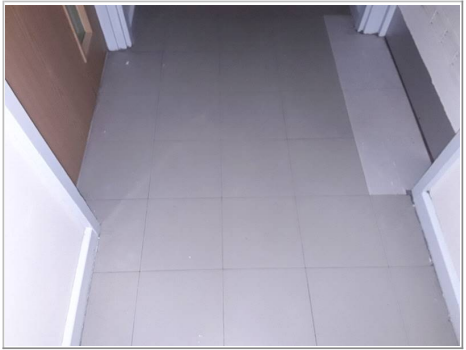
Photo No. 6 - Vinyl floor tiles (light green flecked) and adhesive below			
B 005 Circulation			
Reinforced Composite (1)		Identified	
Chrysotile (1)		D - Manage and Review	
Material Assessment	Very Low	Priority Assessment	Low
-

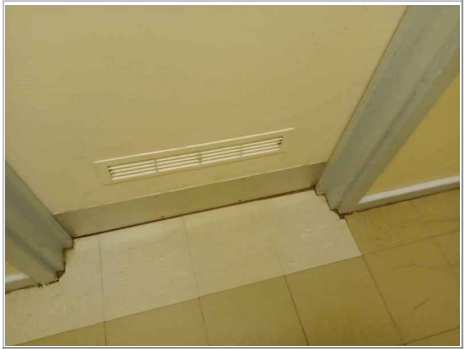
Photo No. 7 - Vinyl floor tiles (orange) below carpet and bitumen adhesive below (as sample DA005541)			
B 006 Office			
Reinforced Composite + Well Bound Material (1)		Strongly Presumed	
Chrysotile (1)		D - Manage and Review	
Material Assessment	Very Low	Priority Assessment	Low
-

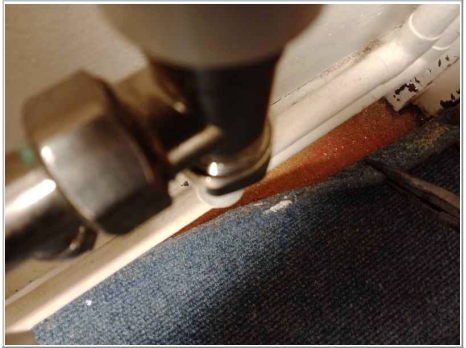
Photo No. 8 - Gaskets to pipework throughout - unable to access to sample

B 007 Boiler Room

Sample prior to disturbance

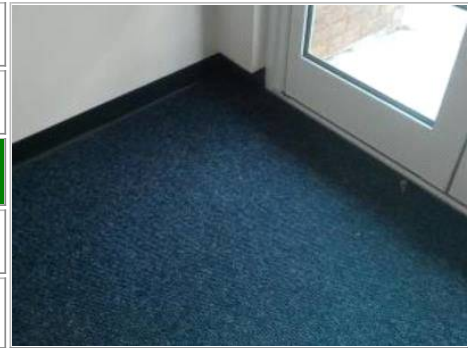
Photo No. 10 - Bitumen adhesive to floor below modern floor sheeting (possibly below new floor covering) (as sample DA005531)

B 011 Circulation

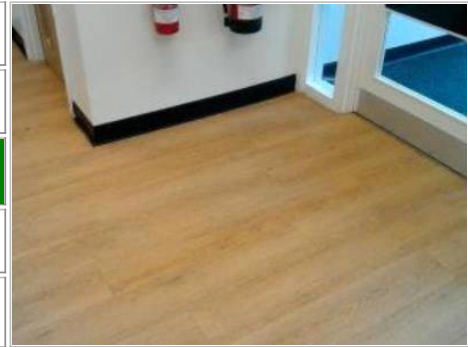
Photo No. 11 - Vinyl floor tiles (green flecked) (as sample DA005534)

B 012 Cleaner's Cupboard

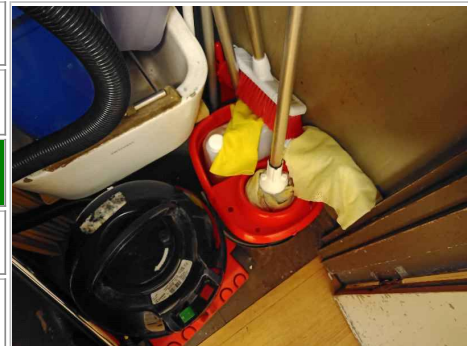
Photo No. 12 - Vinyl floor tiles (green flecked)			
B 013 Store			
Reinforced Composite (1)		Identified	
Chrysotile (1)		D - Manage and Review	
Material Assessment	Very Low	Priority Assessment	Very Low
-

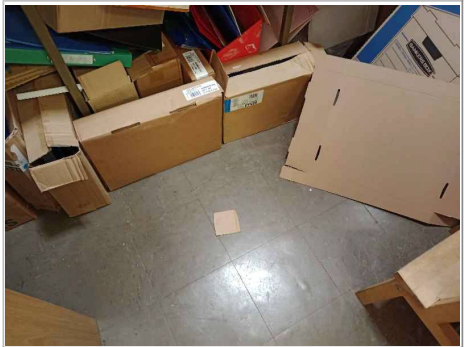
Photo No. 13 - Vinyl floor tiles (green) and bitumen adhesive below (as sample DA005544)			
B 104 Store			
Reinforced Composite + Well Bound Material (1)		Strongly Presumed	
Chrysotile (1)		D - Manage and Review	
Material Assessment	Very Low	Priority Assessment	Low
-

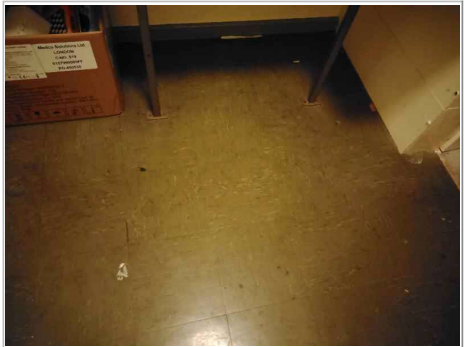
Photo No. 14 - Vinyl floor tiles (green) and bitumen adhesive below			
B 107 Store			
Reinforced Composite + Well Bound Material (1)		Identified	
Chrysotile (1)		D - Manage and Review	
Material Assessment	Very Low	Priority Assessment	Low
-
