## **ASBESTOS REINSPECTION SURVEY REPORT**

**Court Fields School (Block A)  
Mantle Street  
Wellington  
TA21 8SW**

This report details the findings following a reinspection carried out at Court Fields School (Block A), Mantle Street, Wellington TA21 8SW. The reinspection has been carried out to the scope specified in section 3.1 of this report to assess the current condition of the ACMs inspected.

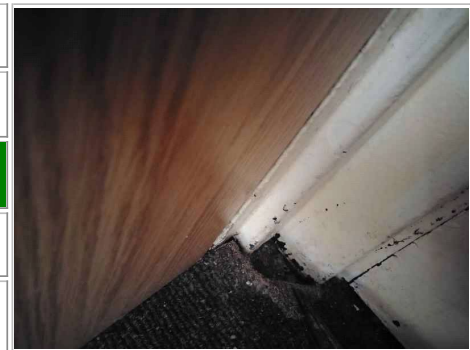
**Photo No. 2 - Bitumen adhesive below carpet**

A 001A Cupboard			
Well Bound Material (1)		Identified	
Chrysotile (1)		<b>D - Manage and Review</b>	
Material Assessment	Very Low	Priority Assessment	Very Low
-

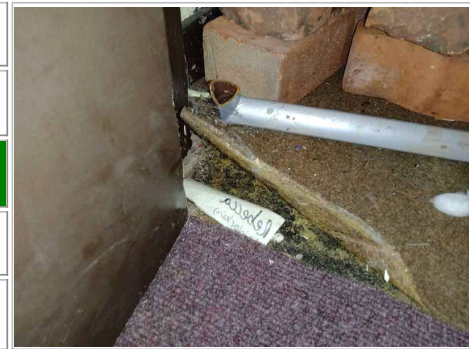
**Photo No. 3 - Paper lining to pipework below glassfibre insulation within riser in ceiling in southwest corner of room (as sample AG001050)**

A 002 Boiler Room			
Asbestos Textiles/Paper (2)		Strongly Presumed	
Chrysotile (1)		<b>D - Manage and Review</b>	
Material Assessment	Low	Priority Assessment	Very Low
-

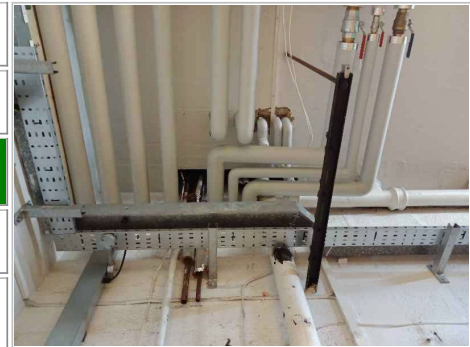
**Photo No. 4 - Insulation residue to wall in northeast area of room (wall adjacent south side of Store A 004) (encapsulated)**

A 002 Boiler Room			
Asbestos Insulation/Coating (3)		Identified	
Chrysotile + Amosite (2)		<b>D - Manage and Review</b>	
Material Assessment	Med	Priority Assessment	Very Low
MANAGED AREA - DO NOT DISTURB WALLS - ENCAPSULATED AI/C RESIDUE PRESENT - SIGNAGE OF WALLS RECOMMENDED

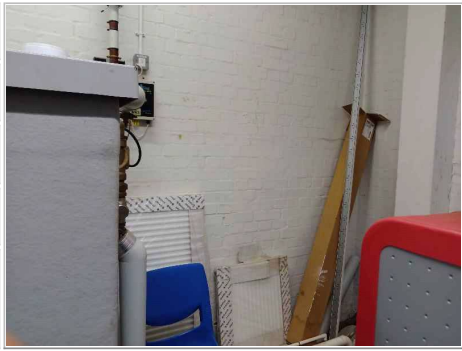
**Photo No. 5 - Insulation residue to walls and old pipework throughout (encapsulated) (as sample AG001120)**

A 002 Boiler Room			
Asbestos Insulation/Coating (3)		Strongly Presumed	
Chrysotile + Amosite (2)		<b>D - Manage and Review</b>	
Material Assessment	Med	Priority Assessment	Very Low
MANAGED AREA - DO NOT DISTURB WALLS - ENCAPSULATED AI/C RESIDUE PRESENT - SIGNAGE OF WALLS RECOMMENDED

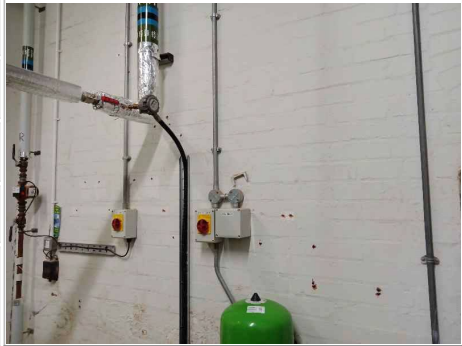
**Photo No. 6 - Insulation residue to pipework hanger in northwest area of room (painted)**

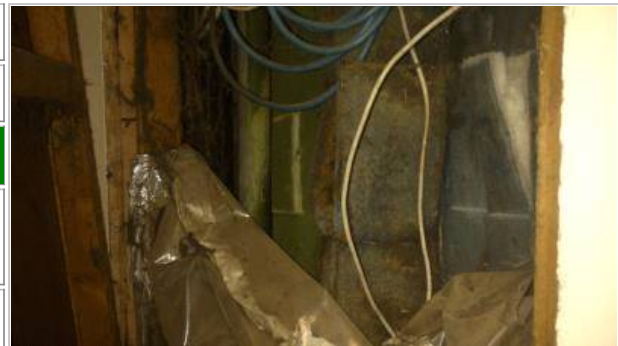
**Photo No. 16 - Paper lining to pipework behind glassfibre insulation within floor duct to east side of room (inspected floor duct from hatch only)\* (as sample AG001050)**

A 015 Circulation			
Asbestos Textiles/Paper (2)		Strongly Presumed	
Chrysotile (1)		<b>D - Manage and Review</b>	
Material Assessment	Low	Priority Assessment	Low
-

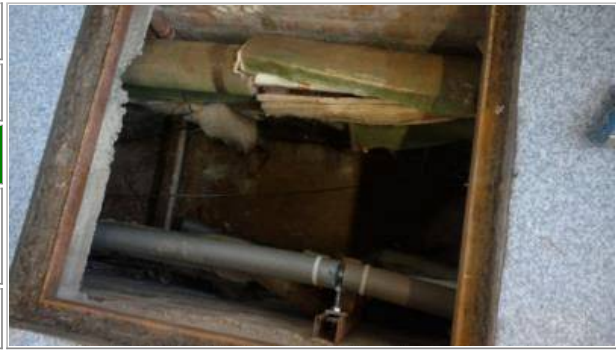
**Photo No. 17 - Paper lining debris within floor duct to east side of room (inspected floor duct from hatch only)\* (as sample AG001050)**

A 015 Circulation			
Asbestos Textiles/Paper (2)		Strongly Presumed	
Chrysotile (1)		<b>C - Repair or Remove</b>	
Material Assessment	Low	Priority Assessment	Low
Removal recommended

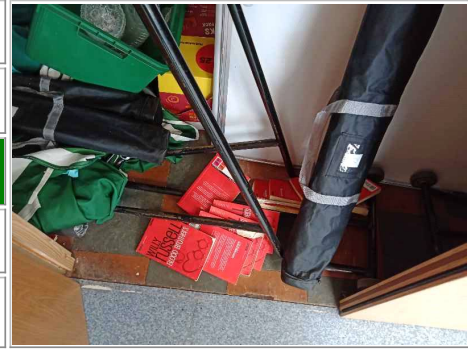
**Photo No. 19 - Vinyl floor tiles (brown) and bitumen adhesive below**

A 024 Store			
Reinforced Composite + Well Bound Material (1)		Identified	
Chrysotile (1)		<b>D - Manage and Review</b>	
Material Assessment	Very Low	Priority Assessment	Very Low
-

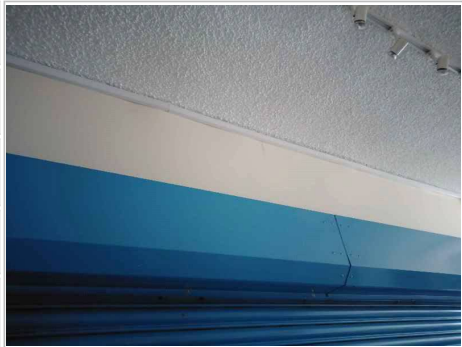
**Photo No. 22 - Fixed wall panels at high level to west side of room (unsealed areas)**

A 026 / A 027 Kitchen / Servery			
Asbestos Insulating Board (2)		Identified	
Amosite (2)		<b>C - Repair or Remove</b>	
Material Assessment	Med	Priority Assessment	Low
Repair/encapsulation recommended

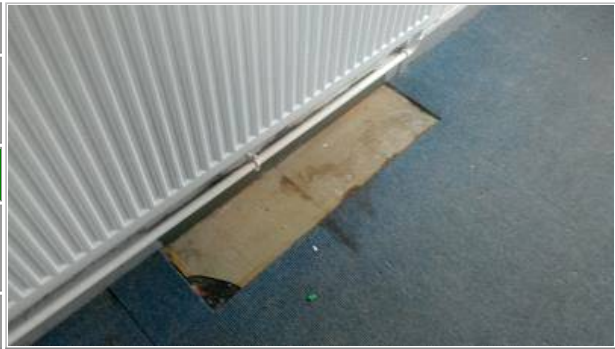
**Photo No. 25 - Bitumen adhesive to floor continuing below screed below carpet (possibly below new floor covering)**

A 038 / A 039 Gym			
Well Bound Material (1)		Identified	
Chrysotile (1)		<b>D - Manage and Review</b>	
Material Assessment	Very Low	Priority Assessment	Low
-

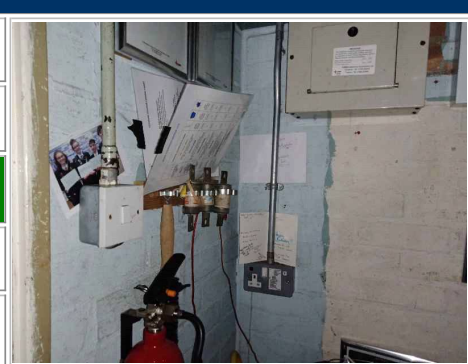
**Photo No. 28 - Wrap to electrical cable - unable to sample for health and safety reasons**

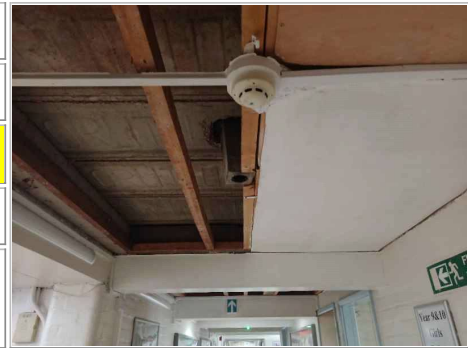
**Photo No. 30 - Residue around nail holes outside Office A 056 to wooden ceiling joists behind plyboard paneling (approx 10-12m2)**

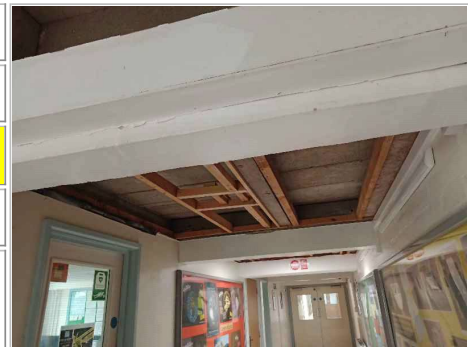
**Photo No. 31 - Residue to timber frame work to ceiling adjacent A 056 and A058 area (sealed behind plyboard)**

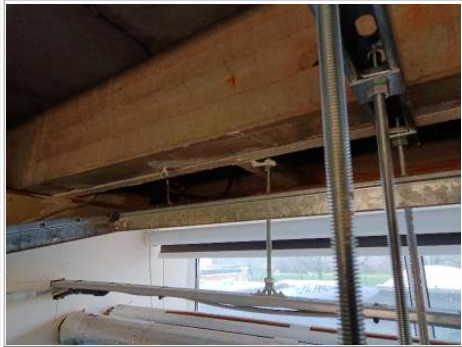
**Photo No. 37 - Panel debris within boxing to west side of room (sampled adjacent high voltage access panel)**

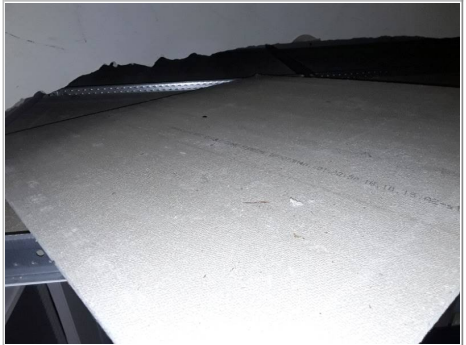
Photo No. 42 - Panel remnants on solid wall to south area of room above suspended ceiling tiles (inspection of ceiling void limited by potential, subsequently proven, contamination - further occurrences may exist in other areas of ceiling void) (as sample AG001054)			
A 056 Office			
Asbestos Insulating Board (2)		Strongly Presumed	
Chrysotile + Amosite (2)		<b>C - Repair or Remove</b>	
Material Assessment	Med	Priority Assessment	Low
MANAGED AREA - AREA MUST NOT BE ACCESSED UNTIL REMEDIAL ACTION HAS BEEN CARRIED OUT

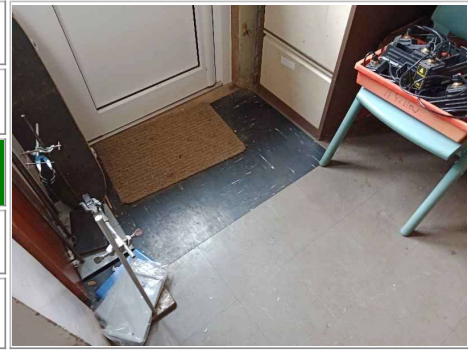
**Photo No. 50 - Vinyl floor tiles (grey) and bitumen adhesive below (as sample AQ001882)**

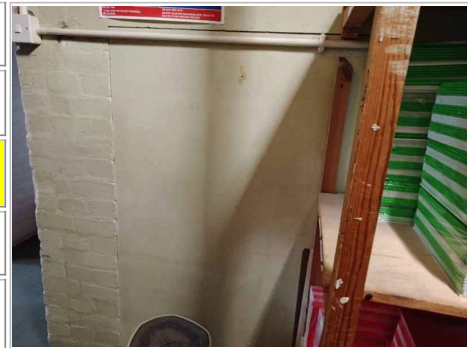
**Photo No. 52 - Fixed wall panel to east side of room (small areas require remedial action) (as sample AQ001890)**

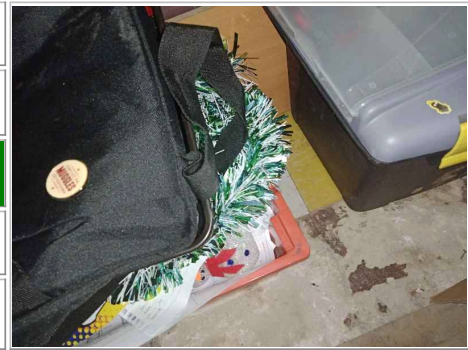
Photo No. 60 - Vinyl floor tiles (light grey) and adhesive below			
A 101A Cupboard			
Reinforced Composite (1)		Identified	
Chrysotile (1)		<b>D - Manage and Review</b>	
Material Assessment	Very Low	Priority Assessment	Very Low
-

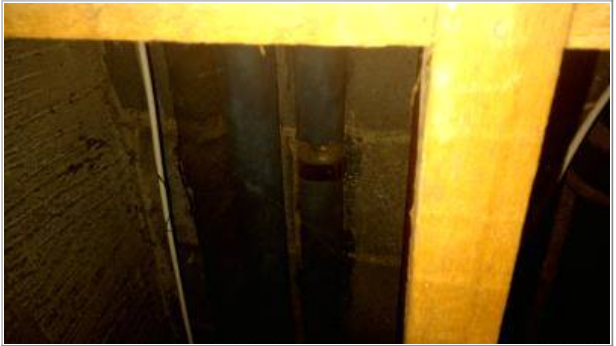
Photo No. 62 - No access into riser to southwest corner of room due to surface mounted pipes			
A 103 W.C.			
		Inaccessible (Presumed)	
		<b>E - Inspect Prior to Disturbance</b>	
Material Assessment	N/A	Priority Assessment	N/A
-

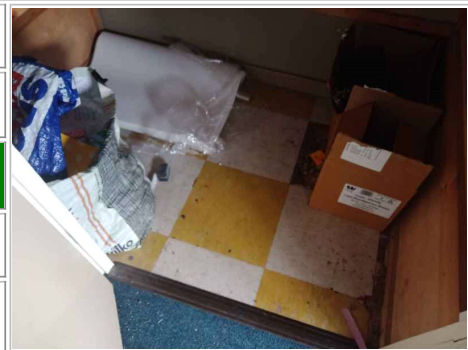
**Photo No. 72 - Vinyl floor tiles (light grey) and adhesive below (as sample AQ001903)**

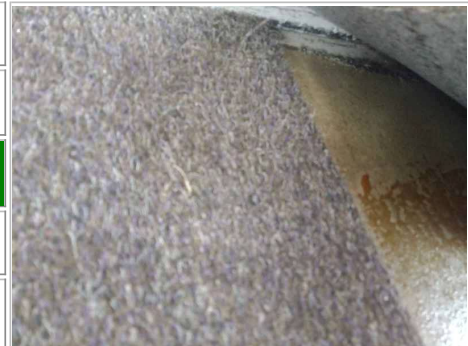
A 108 Office - No access into wall cavity behind horizontal boxing to south side of room without causing significant damage

**Photo No. 76 - No access into wall cavity behind horizontal boxing to south side of room without causing significant damage**

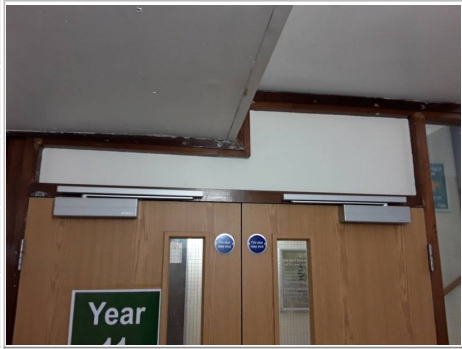
A 112 Circulation / Stairs - No access behind boxing adjacent ceiling without causing significant damage

**Photo No. 79 - No access behind boxing adjacent ceiling without causing significant damage**

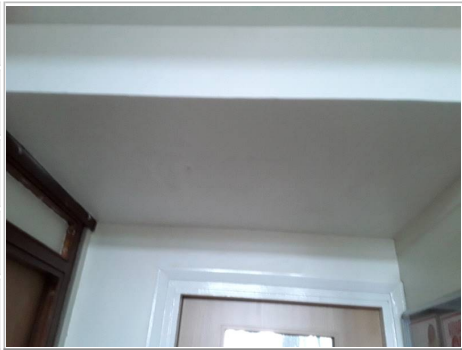
**Photo No. 80 - Infill panels behind timber panelling to east wall**

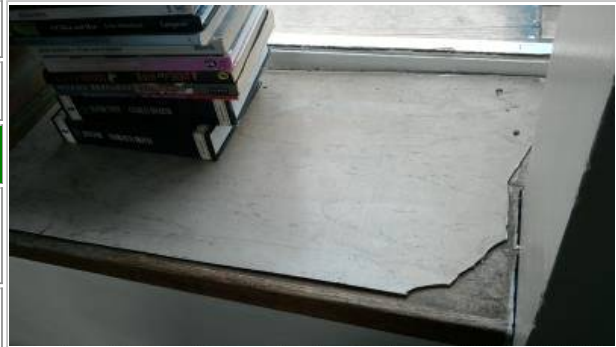
**Photo No. 87 - Vinyl sheeting (grey) to window sills to south side of room (possibly below new PVC window sills) (as sample AQ001942)**

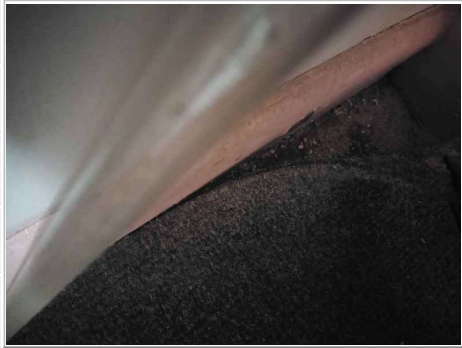
**Photo No. 92 - Panel remnants between tops of walls and ceiling throughout ceiling void**

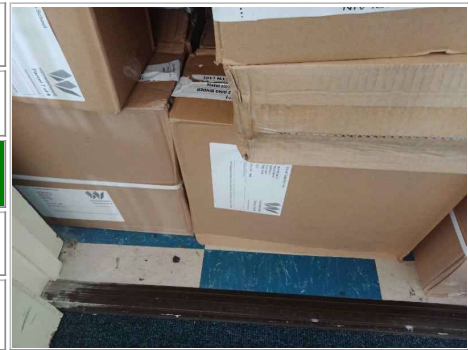
**Photo No. 98 - Vinyl floor tiles (blue) (as sample AQ001968)**

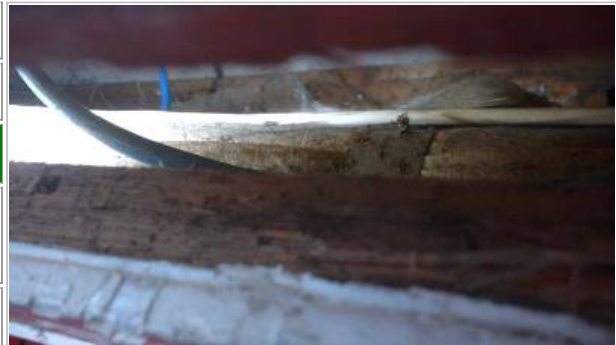
Photo No. 111 - Soffit boards to north, south and east sides of eastern area of second floor
