ASBESTOS REINSPECTION SURVEY REPORT

Court Fields School (Block B)
Mantle Street
Wellington
TA21 8SW

Type of Report: Reinspection Survey
Project / Job Number: RSP / O000694 / J146184
Client Order Number: 8005
Quote Number: O000694
Sample Number(s): No samples were taken during the course of this survey.
Reinspection Date(s): 7 Aug 2024
Report Date: 29 Aug 2024

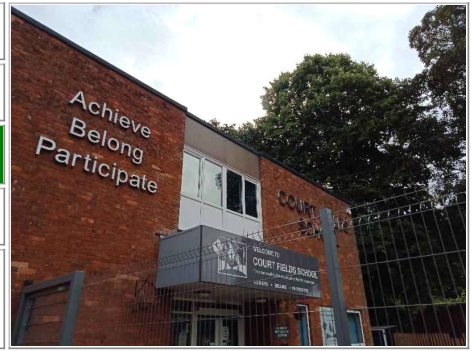
Photo No. 16 - Fixed wall panels above windows to west side of Classrooms B 101 and B 106 - unable to reach to sample

External			
Asbestos Cement (1)		Presumed	
Crocidolite (or unknown) (3)		D - Manage and Review	
Material Assessment	Low	Priority Assessment	Very Low
Partially removed - date and contractor unknown - Sample prior to disturbance
