## **ASBESTOS REINSPECTION SURVEY REPORT**

**Court Fields School (Block A)  
Mantle Street  
Wellington  
TA21 8SW**

This report details the findings following a reinspection carried out at Court Fields School (Block A), Mantle Street, Wellington TA21 8SW. The reinspection has been carried out to the scope specified in section 3.1 of this report to assess the current condition of the ACMs inspected.

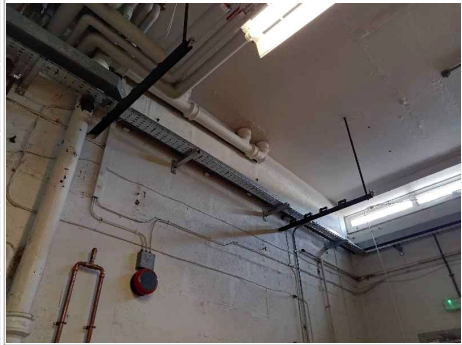
**Photo No. 6 - Insulation residue to pipework hanger in northwest area of room (painted)**

A 002 Boiler Room			
Asbestos Insulation/Coating (3)		Identified	
Chrysotile + Amosite (2)		<b>D - Manage and Review</b>	
Material Assessment	Med	Priority Assessment	Low
-

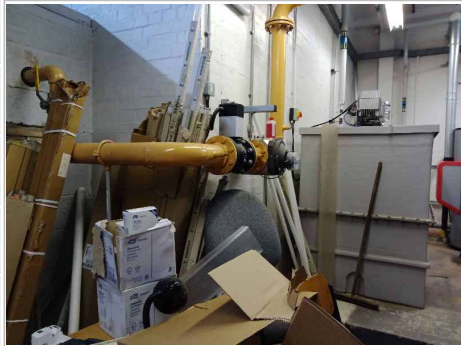
**Photo No. 7 - Gaskets to gas pipeline - unable to access to sample**

A 002 Boiler Room			
Asbestos Textiles/Paper (2)		Presumed	
Chrysotile (1)		<b>D - Manage and Review</b>	
Material Assessment	Low	Priority Assessment	Very Low
Sample prior to disturbance

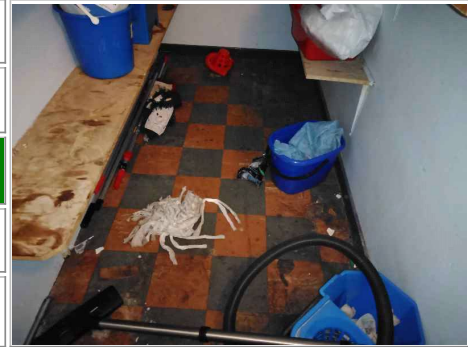
**Photo No. 8 - Vinyl floor tiles (blue/grey) (as sample AQ001873)**

A 008 Understairs Cupboard			
Reinforced Composite (1)		Strongly Presumed	
Chrysotile (1)		<b>D - Manage and Review</b>	
Material Assessment	Very Low	Priority Assessment	Very Low
-

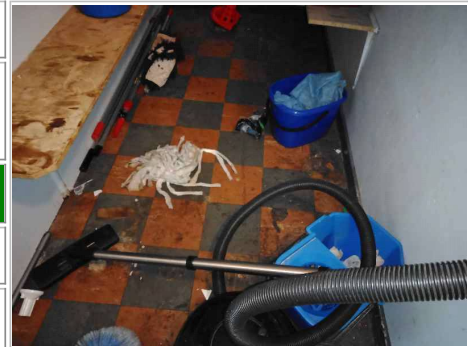
**Photo No. 9 - Vinyl floor tiles (brown) and bitumen adhesive below (as sample AQ001874)**

A 008 Understairs Cupboard			
Reinforced Composite + Well Bound Material (1)		Strongly Presumed	
Chrysotile (1)		<b>D - Manage and Review</b>	
Material Assessment	Very Low	Priority Assessment	Very Low
-

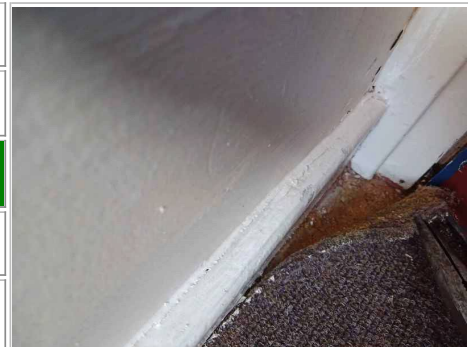
**Photo No. 10 - Bitumen adhesive below carpet (as sample AQ001875)**

A 011 Careers Office			
Well Bound Material (1)		Strongly Presumed	
Chrysotile (1)		<b>D - Manage and Review</b>	
Material Assessment	Very Low	Priority Assessment	Low
-

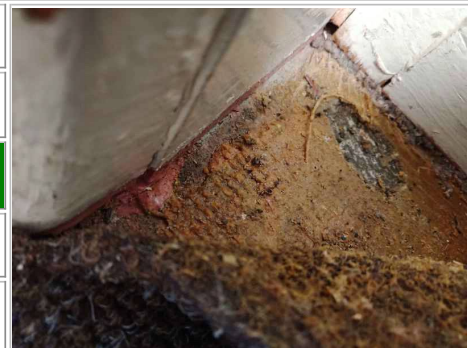
**Photo No. 11 - Bitumen adhesive below carpet to south area of room**

A 012 Store			
Well Bound Material (1)		Identified	
Chrysotile (1)		<b>D - Manage and Review</b>	
Material Assessment	Very Low	Priority Assessment	Low
-

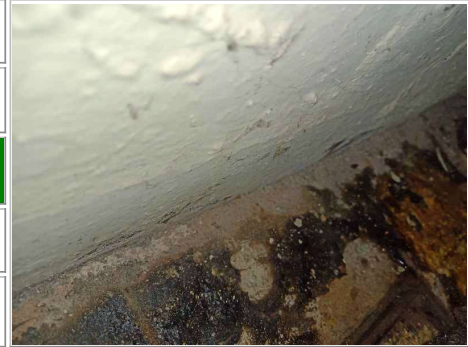
Photo No. 12 - Bitumen adhesive below carpet (as sample AQ001878)

A 013A Cupboard			
Well Bound Material (1)		Strongly Presumed	
Chrysotile (1)		<b>D - Manage and Review</b>	
Material Assessment	Very Low	Priority Assessment	Very Low
-

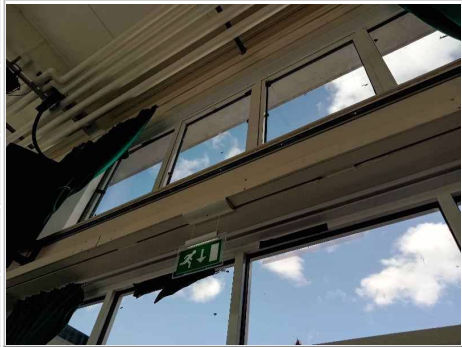
**Photo No. 20 - Packing panels between metal conduit and wall at high level to east side of room**

A 025 Assembly Hall			
Asbestos Insulating Board (2)		Identified	
Chrysotile + Amosite (2)		<b>D - Manage and Review</b>	
Material Assessment	Low	Priority Assessment	Low
-

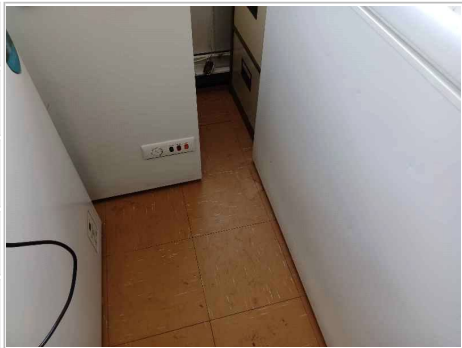
**Photo No. 23 - Vinyl floor tiles (beige) to floor and side of window sill and bitumen adhesive below**

A 033 Office			
Well Bound Material (1)		Identified	
Chrysotile (1)		<b>D - Manage and Review</b>	
Material Assessment	Very Low	Priority Assessment	Low
-

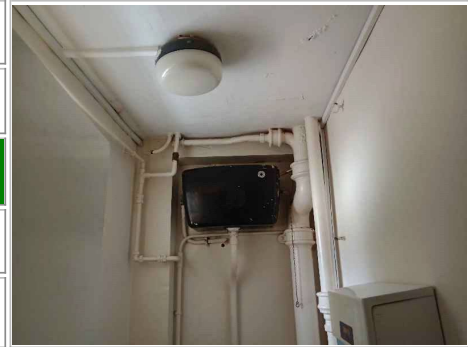
**Photo No. 26 - Toilet cistern**

A 046 W.C.			
Reinforced Composite (1)		Identified	
Amosite (2)		<b>D - Manage and Review</b>	
Material Assessment	Very Low	Priority Assessment	Low
-

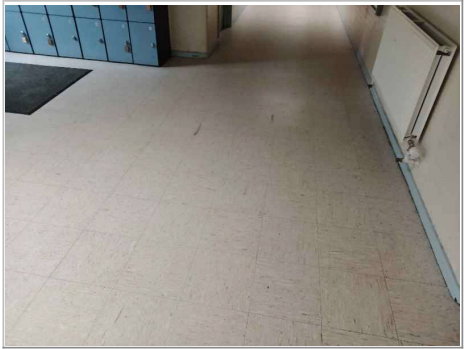
**Photo No. 32 - Vinyl floor tiles (grey) and bitumen adhesive below (as sample AQ001883)**

A 048A Circulation			
Well Bound Material (1)		Strongly Presumed	
Chrysotile (1)		<b>D - Manage and Review</b>	
Material Assessment	Very Low	Priority Assessment	Low
-

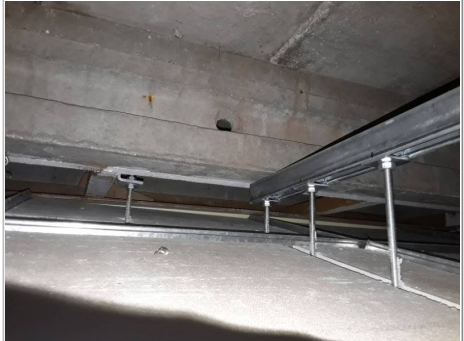
**Photo No. 35 - Residue to timber frame above suspended ceiling tiles to north side of room (encapsulated)**

A 054 Science Lab - B3			
Asbestos Insulating Board (2)		Identified	
Chrysotile + Amosite (2)		<b>D - Manage and Review</b>	
Material Assessment	Low	Priority Assessment	Low
-

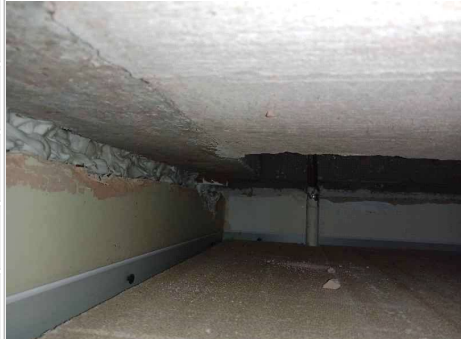
**Photo No. 39 - Panel residue to surfaces / areas at top of solid wall to south side of room and to top of cylindrical metal conduit housing cables above suspended ceiling grid (residue is surface sealed with silicone at top of wall and with multi-purpose filler on the conduit)**

A 056 Office			
Asbestos Insulating Board (2)		Identified	
Chrysotile + Amosite (2)		<b>D - Manage and Review</b>	
Material Assessment	Med	Priority Assessment	Low
-

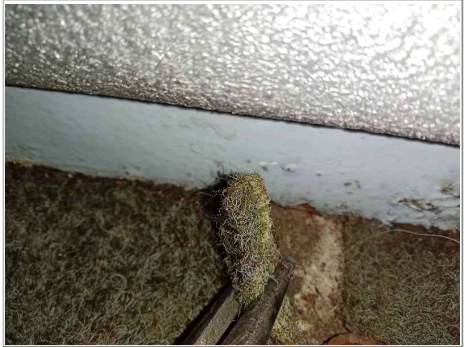
Photo No. 40 - Bitumen adhesive below carpet			
A 056 Office			
Well Bound Material (1)		Identified	
Chrysotile (1)		<b>D - Manage and Review</b>	
Material Assessment	Very Low	Priority Assessment	Low
-

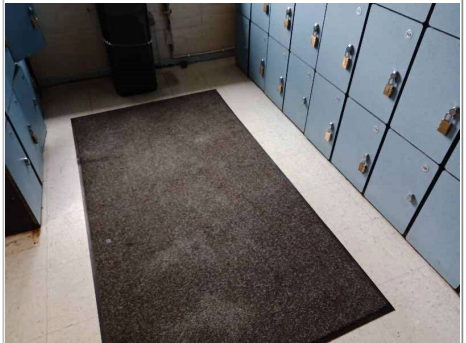
Photo No. 43 - Vinyl floor tiles (light grey) and bitumen adhesive below			
A 058 Locker Area			
Well Bound Material (1)		Identified	
Chrysotile (1)		<b>D - Manage and Review</b>	
Material Assessment	Very Low	Priority Assessment	Low
-

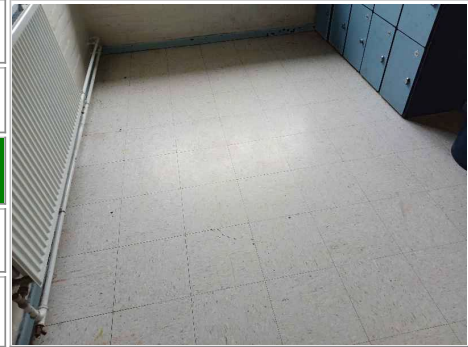
**Photo No. 44 - Vinyl floor tiles (light grey) and bitumen adhesive below (as sample AQ001883)**

A 060 Waiting Area

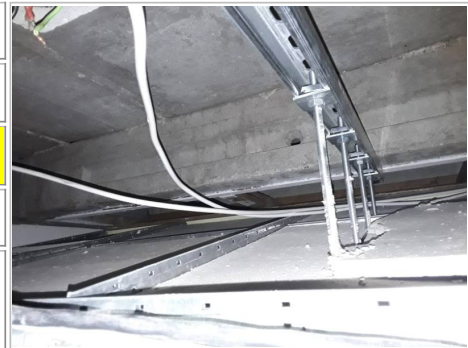
**Photo No. 47 - Residue to timber frame throughout east area above suspended ceiling tiles (as sample AQ001885)**

A 062 Science Lab - B4

**MANAGED AREA - AREA MUST NOT BE ACCESSED UNTIL REMEDIAL ACTION HAS BEEN CARRIED OUT**

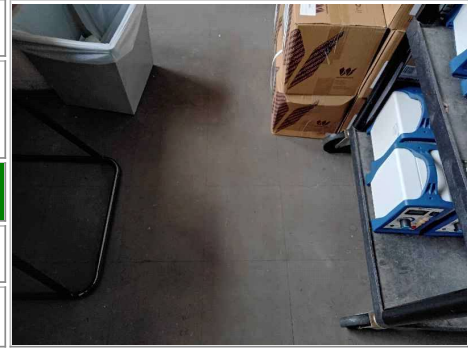
**Photo No. 48 - Vinyl floor tiles (grey) and bitumen adhesive below (as sample AQ001882)**

A 063 Prep Room			
Reinforced Composite + Well Bound Material (1)		Strongly Presumed	
Chrysotile (1)		<b>D - Manage and Review</b>	
Material Assessment	Very Low	Priority Assessment	Low
-

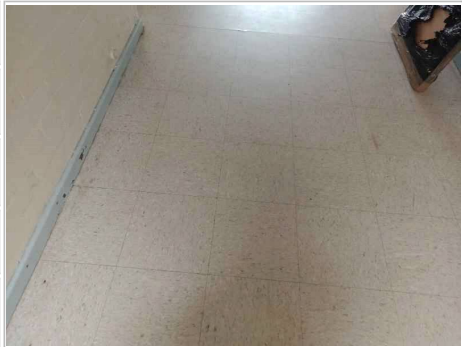
**Photo No. 53 - Vinyl floor tiles (light grey) and bitumen adhesive below (as sample AQ001883)**

A 067 Circulation			
Well Bound Material (1)		Strongly Presumed	
Chrysotile (1)		<b>D - Manage and Review</b>	
Material Assessment	Very Low	Priority Assessment	Low
-

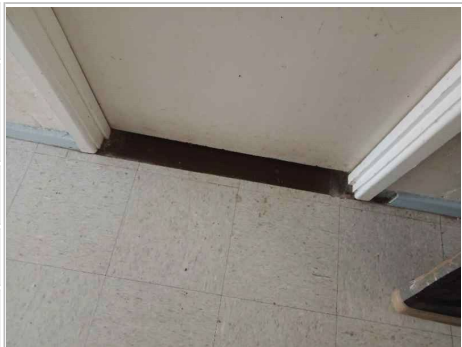
**Photo No. 54 - Vinyl floor tiles (brown) adjacent door thresholds to north side of room and bitumen adhesive below**

A 067 Circulation			
Reinforced Composite + Well Bound Material (1)		Identified	
Chrysotile (1)		<b>D - Manage and Review</b>	
Material Assessment	Very Low	Priority Assessment	Low
-

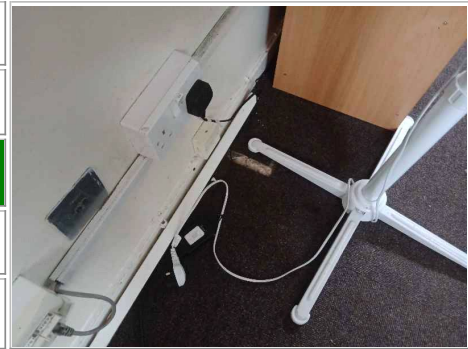
**Photo No. 55 - Fixed panels above heater within boxing in southeast corner of room**

A 073 Classroom - B5			
Asbestos Cement (1)		Identified	
Chrysotile (1)		<b>D - Manage and Review</b>	
Material Assessment	Very Low	Priority Assessment	Low
-

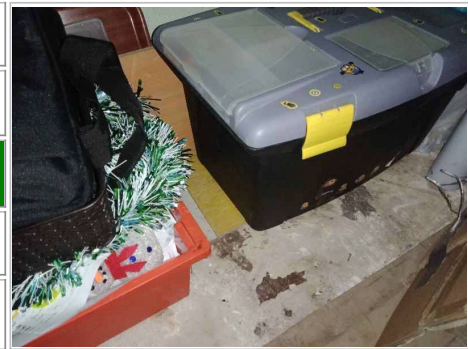
**Photo No. 57 - Bitumen adhesive to window sill to west side of room where vinyl sheeting has been removed (as sample AQ001900)**

A 101 Classroom - B15

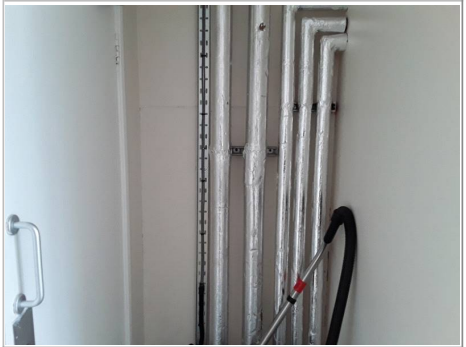
Photo No. 62 - No access into riser to southwest corner of room due to surface mounted pipes			
A 103 W.C.			
		Inaccessible (Presumed)	
		<b>E - Inspect Prior to Disturbance</b>	
Material Assessment	N/A	Priority Assessment	N/A
-

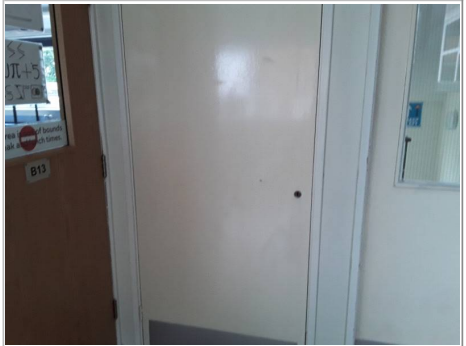
Photo No. 63 - No access - no key available at time of survey			
A 104A Cupboard			
		Inaccessible (Presumed)	
		<b>E - Inspect Prior to Disturbance</b>	
Material Assessment	N/A	Priority Assessment	N/A
-

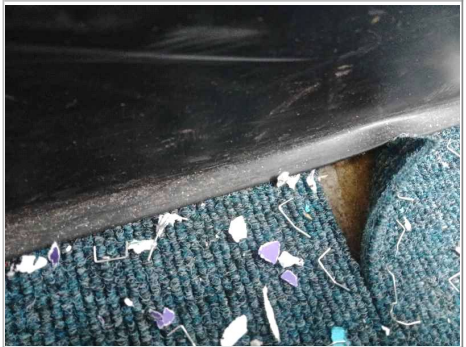
**Photo No. 64 - Bitumen adhesive below carpet tiles continuing below screed**

A 105 Classroom - B13			
Well Bound Material (1)		Identified	
Chrysotile (1)		<b>D - Manage and Review</b>	
Material Assessment	Very Low	Priority Assessment	Low
-

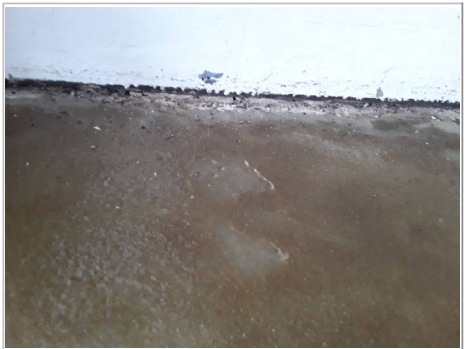
**Photo No. 65 - Vinyl floor tile remnants (grey) below skirting board (sampled to east side of room)**

A 105 Classroom - B13			
Reinforced Composite (1)		Identified	
Chrysotile (1)		<b>D - Manage and Review</b>	
Material Assessment	Very Low	Priority Assessment	Low
-

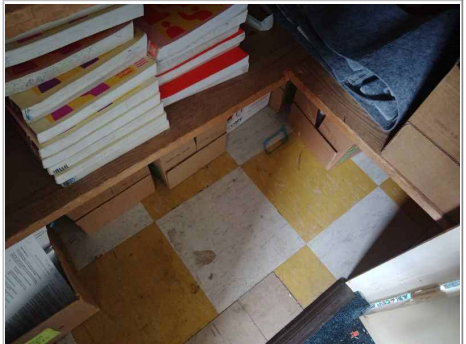
**Photo No. 67 - Vinyl floor tiles (yellow) and adhesive below (as sample AQ001901)**

A 105A Cupboard			
Reinforced Composite (1)		Strongly Presumed	
Chrysotile (1)		<b>D - Manage and Review</b>	
Material Assessment	Very Low	Priority Assessment	Very Low
-

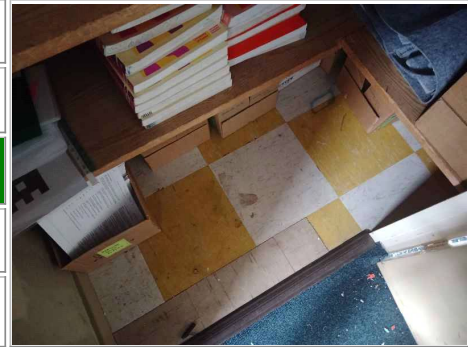
Photo No. 68 - Vinyl floor tiles (grey) and adhesive below (as sample AQ001902)

A 105A Cupboard			
Reinforced Composite (1)		Strongly Presumed	
Chrysotile (1)		<b>D - Manage and Review</b>	
Material Assessment	Very Low	Priority Assessment	Very Low
-

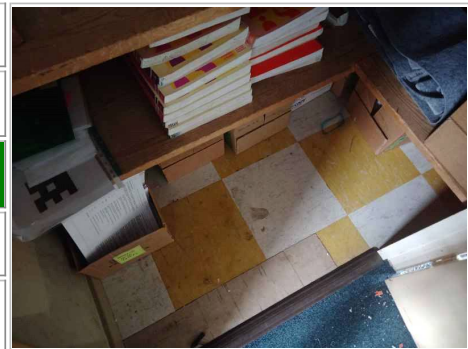
Photo No. 69 - Vinyl floor tiles (light grey) and adhesive below (as sample AQ001903)

A 105A Cupboard			
Reinforced Composite (1)		Strongly Presumed	
Chrysotile (1)		<b>D - Manage and Review</b>	
Material Assessment	Very Low	Priority Assessment	Very Low
-

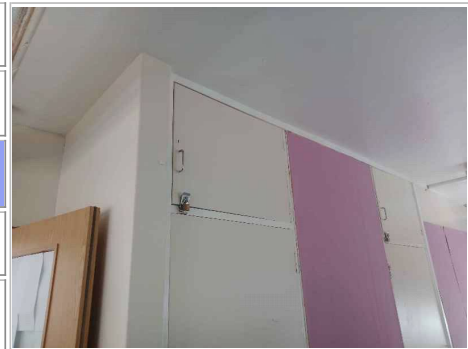
Photo No. 70 - No access into top cupboard - no key available at time of survey

A 105A Cupboard			
		Inaccessible (Presumed)	
		<b>E - Inspect Prior to Disturbance</b>	
Material Assessment	N/A	Priority Assessment	N/A
-

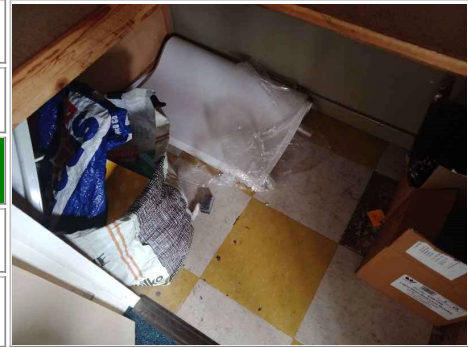
**Photo No. 72 - Vinyl floor tiles (light grey) and adhesive below (as sample AQ001903)**

A 105B Cupboard			
Reinforced Composite (1)		Strongly Presumed	
Chrysotile (1)		<b>D - Manage and Review</b>	
Material Assessment	Very Low	Priority Assessment	Very Low
-

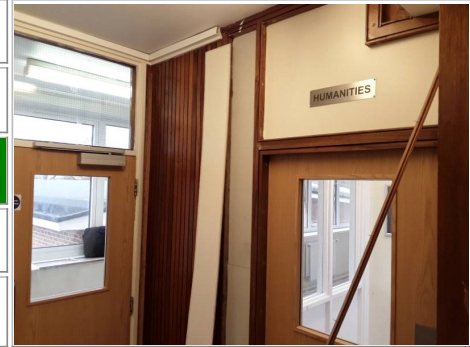
**Photo No. 81 - Infill panels behind timber panelling to west wall (as sample DG004861)**

A 114 Circulation

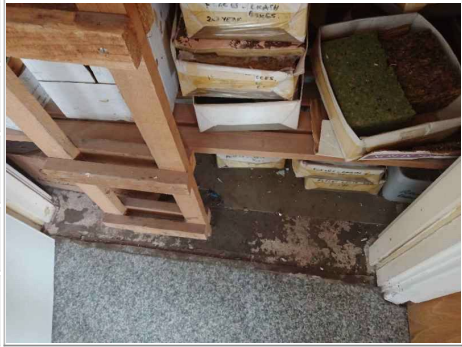
**Photo No. 91 - Bitumen adhesive below modern screed below carpet**

A 126 Prep Room			
Well Bound Material (1)		Identified	
Chrysotile (1)		<b>D - Manage and Review</b>	
Material Assessment	Very Low	Priority Assessment	Low
-

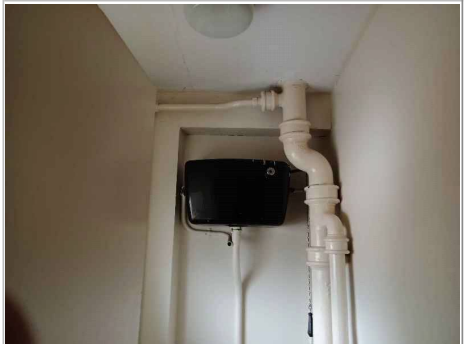
**Photo No. 96 - Paper lining to pipework below glassfibre insulation within riser in southwest corner of room\* (as sample AG001058)**

A 202 Store			
Asbestos Textiles/Paper (2)		Strongly Presumed	
Chrysotile (1)		<b>D - Manage and Review</b>	
Material Assessment	Low	Priority Assessment	Low
-

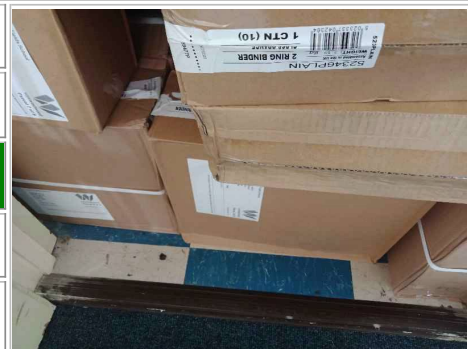
**Photo No. 99 - Vinyl floor tiles (black) and bitumen adhesive below**

A 207 Store			
Reinforced Composite + Well Bound Material (1)		Identified	
Chrysotile (1)		<b>D - Manage and Review</b>	
Material Assessment	Very Low	Priority Assessment	Low
-

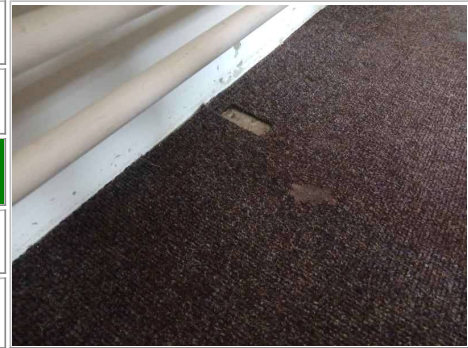
**Photo No. 102 - Vinyl floor tiles (beige) below carpet and modern screed and bitumen adhesive below**

A 208 Classroom - B18			
Reinforced Composite (1)		Identified	
Chrysotile (1)		<b>D - Manage and Review</b>	
Material Assessment	Very Low	Priority Assessment	Low
-

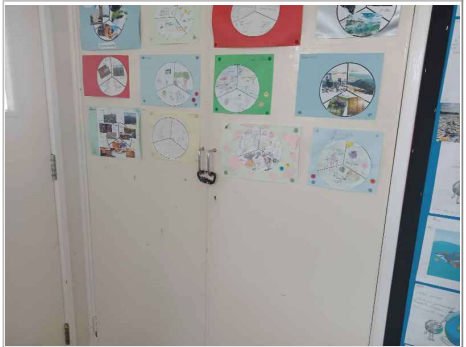
Photo No. 105 - Vinyl floor tiles (blue)			
A 208A Cupboard			
Reinforced Composite (1)		Identified	
Chrysotile (1)		<b>D - Manage and Review</b>	
Material Assessment	Very Low	Priority Assessment	Very Low
-

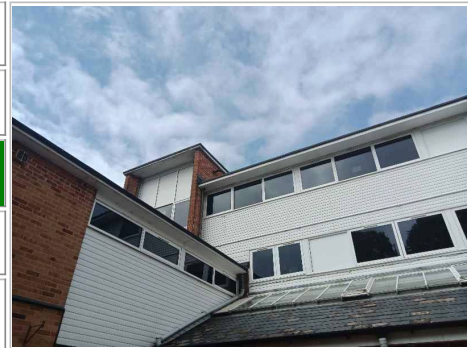
Photo No. 115 - Cement cowl to southwest corner of water tank room at high level (as sample DH001918)

External			
Asbestos Cement (1)		Strongly Presumed	
Chrysotile (1)		<b>D - Manage and Review</b>	
Material Assessment	Very Low	Priority Assessment	Very Low
Sample prior to disturbance
